16 SECTION 17 TOWN 05 RANGE

ADAMS COUNTY

COUNTY CORNER NO: 57
ROMPORTOL ID: 41705162000

PUBLIC LAND SURVEY MONUMENT RECORD

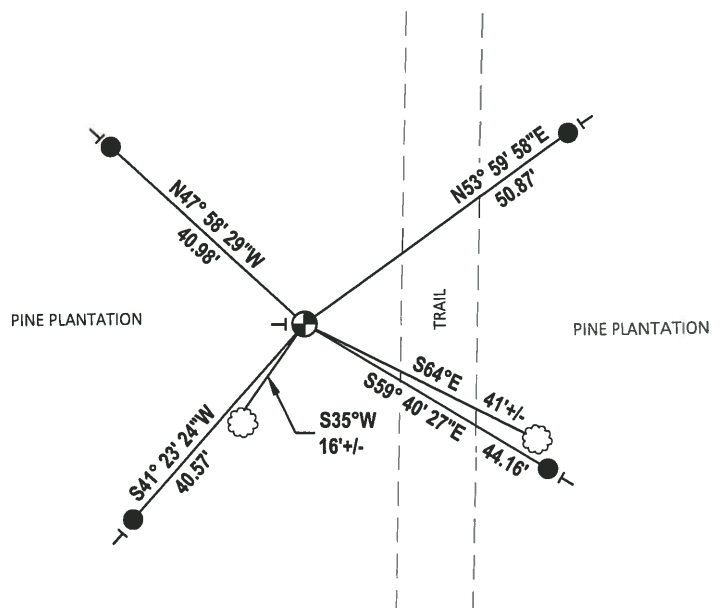
TIE SKETCH

2019 - PLS 2675 FOUND A HARRISON MONUMENT WITH A BROKEN-TOP 6" BELOW THE GROUND SURFACE AND 2 WITNESS TREES. THE MONUMENT AGREES WITH THE EXISTING WITNESS TREES. ACCEPTED THE HARRISON MONUMENT WITH A BROKEN-TOP AS THE CORNER LOCATION. SET 4 NEW TIES AND MEASURED TO THE TIES AND WITNESS TREES.

NOTE: THE CORNER FALLS 16'± WEST OF THE TRAIL.

- SET 3/4" x 18" IRON REBAR, 1.50#/FT
- ⊕ FOUND HARRISON MONUMENT (BROKEN-TOP)
- └ VINYL "T" POST
- ☁ WITNESS TREE

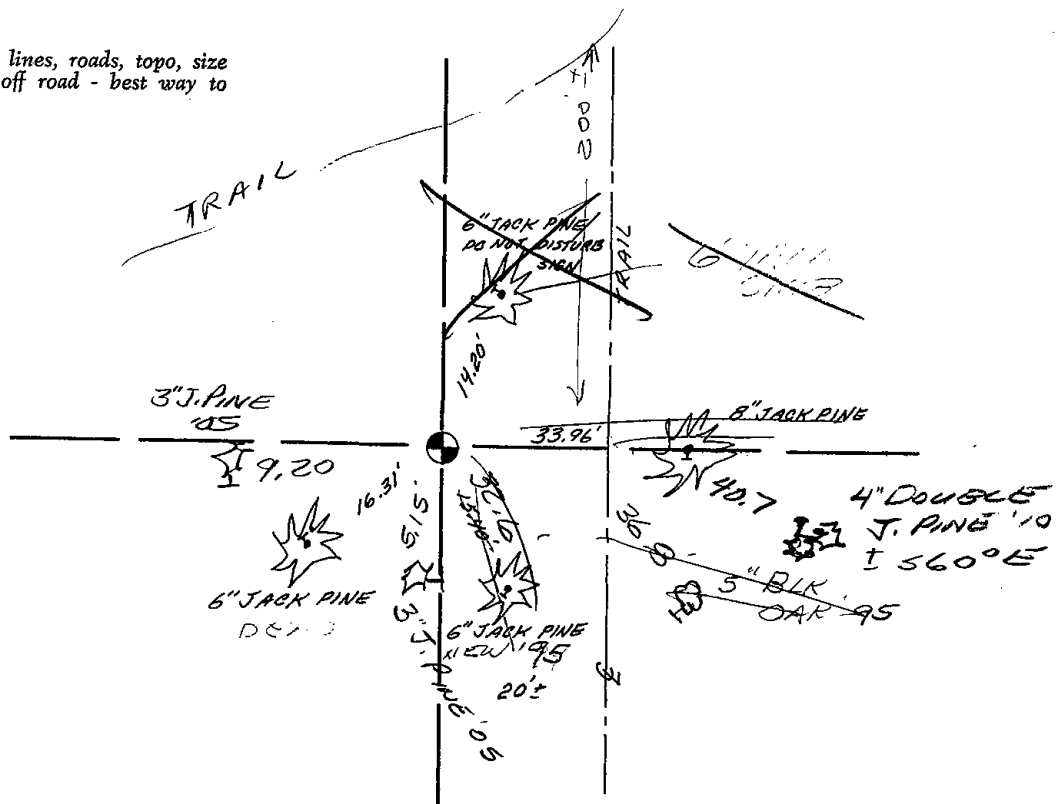
TIE SKETCH

This corner was set equidistant and on line between section corners. No evidence of original corner or any resurvey corner.

ALL OK 7-2-85 DK
 OK 1-29-90 KZ-SS

2 GONE - 2 NEW 1-3-95 BS-SS
 AREA PULPED & REPLANTED - 2 TIES IN
 DEAD TREES REMAIN - SHOULD SPRING
 STEEL POST NEXT TRIP IN - 1-6-00 SIS
 2 NEW TIES - TOP BROKEN OFF MON 2-10-05 JG-SS
 STEEL POST/SIGN IMMEDIATELY WEST
 1 NEW TIE 2-16-10 SS
