26 SECTION 17 TOWN 05 RANGE

ADAMS COUNTY

COUNTY CORNER NO: 99
 ROMPORTOL ID: 41705262000

PUBLIC LAND SURVEY MONUMENT RECORD

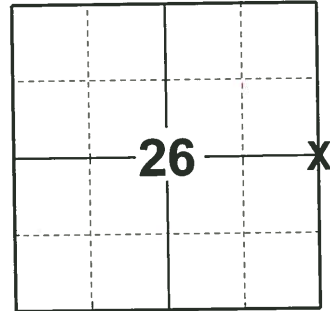
LOCATION

(INDICATE CORNER BY "X")

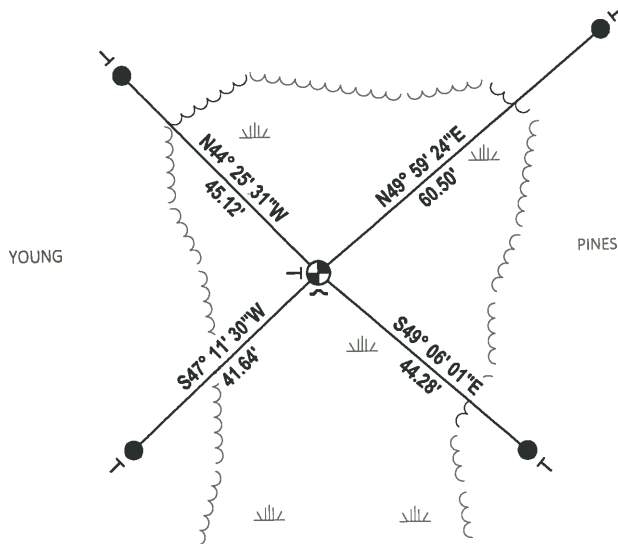
- TIE SKETCH

2019 - PLS-2675 FOUND HARRISON MONUMENT (BROKEN-TOP) 6" BELOW THE WATER LINE, DID NOT RECOVER ANY TIES OR WITNESS. THE MONUMENT WAS VERIFIED TO BE ON A NEAR STRAIGHT LINE AND EQUIDISTANT BETWEEN THE NE AND SE CORNERS OF SECTION 26. ACCEPTED THE HARRISON MONUMENT (BROKEN-TOP) AS THE CORNER AND SET 4 NEW TIES.

- SET 3/4" x 18" IRON REBAR, 1.50#/FT
- ⊕ FOUND HARRISON MONUMENT (BROKEN-TOP)
- ~ STEEL FENCE POST
- VINYL "T" POST

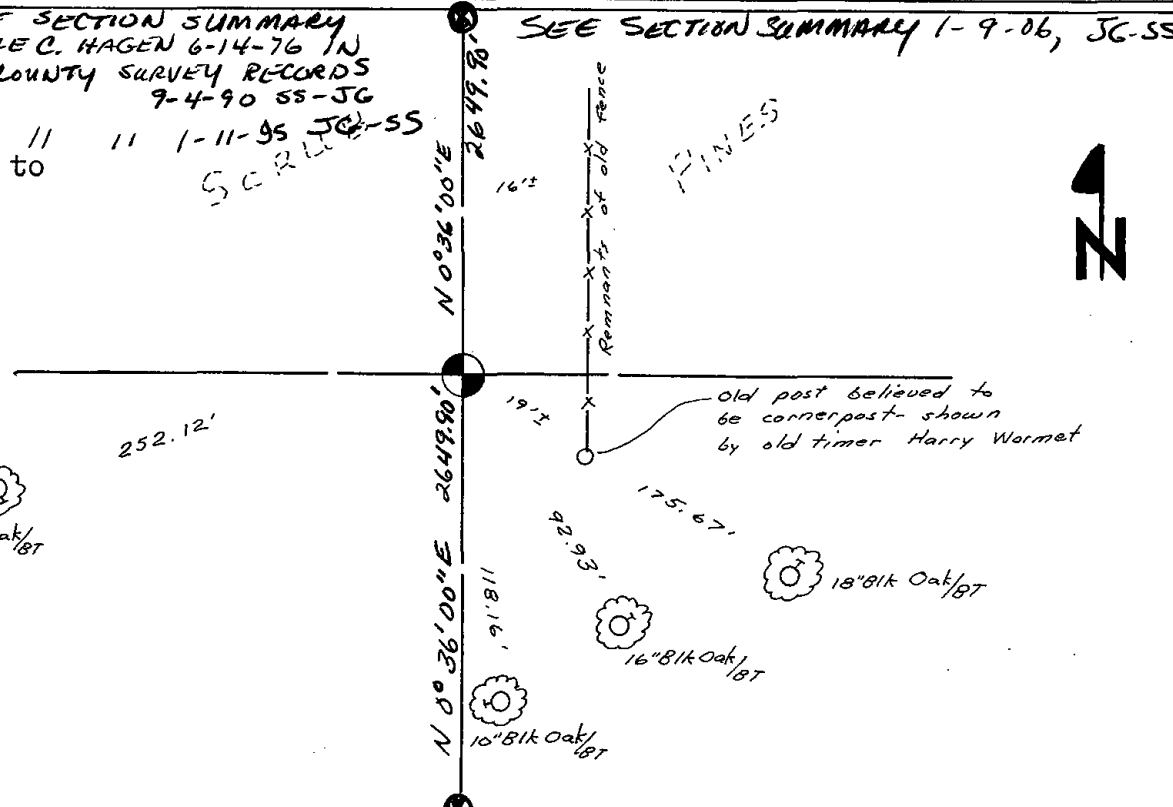
TIE SKETCH SEE SECTION SUMMARY DALE C. HAGEN 6-14-76 IN COUNTY SURVEY RECORDS 9-4-90 SS-JG

Ties in trees to nail in disc.
