ADAMS COUNTY

COUNTY CORNER NO: 109
ROMPORTOL ID: 41705270000

PUBLIC LAND SURVEY MONUMENT RECORD

CORNER NO. 873
SECTION 35
TOWN 17N
RANGE 5E

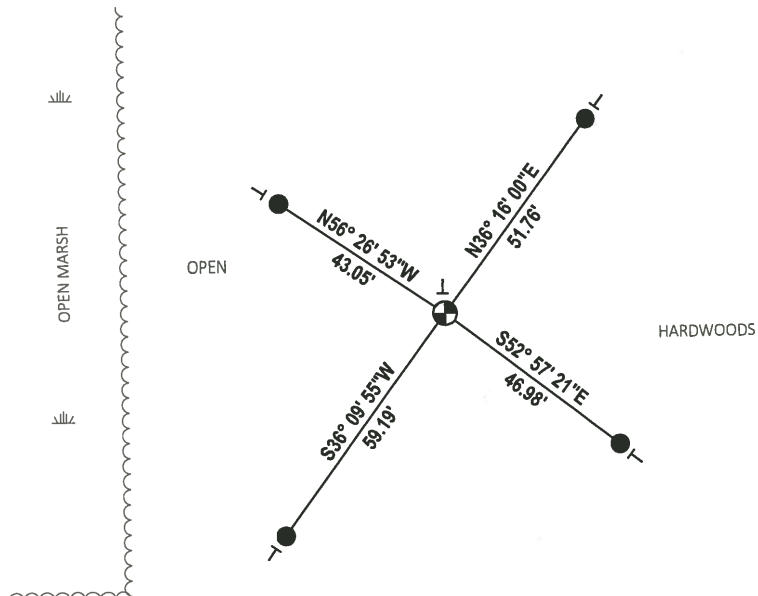
- TIE SKETCH

2019 - PLS-2675 FOUND HARRISON MONUMENT 4" ABOVE THE GROUND AND DID NOT RECOVER ANY WITNESS OR TIES. ACCEPTED THE HARRISON MONUMENT AS THE CORNER. SET 4 NEW TIES.

NOTE: THE CORNER LAND 200± EAST OF THE OPEN MARSH

- SET 3/4" x 18" IRON REBAR, 1.50#/FT
- ⊕ FOUND HARRISON MONUMENT
- VINYL "T" POST

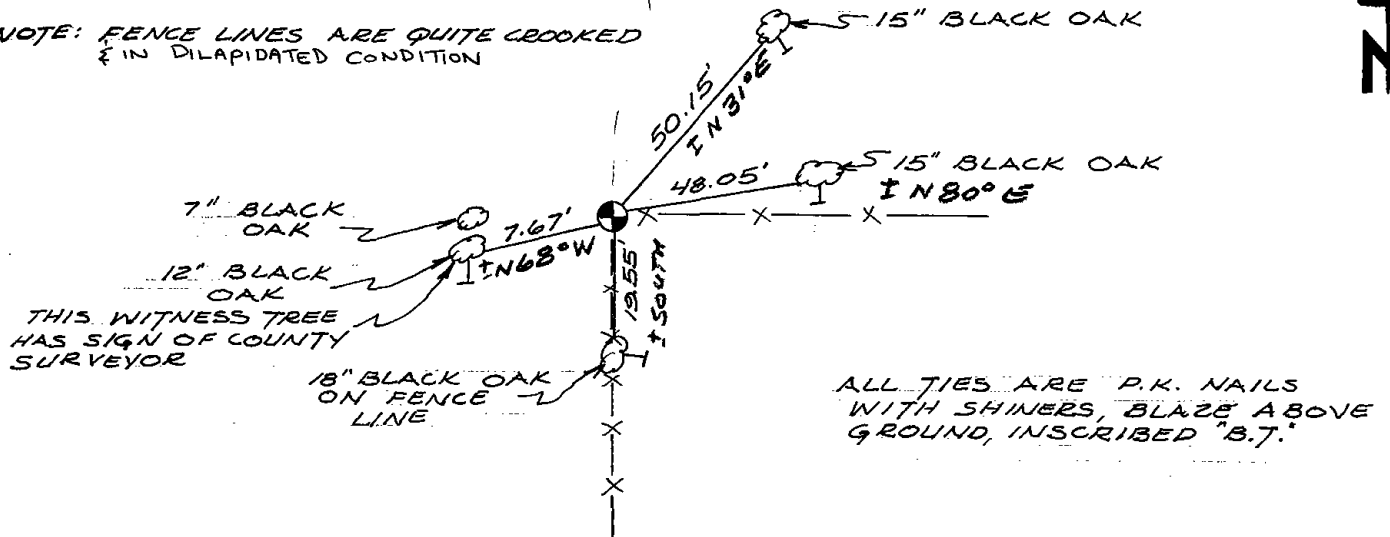
TIE SKETCH

* 5' TALL
NORWAY 1990

200'± South (PINE PLANTINGS - few rows top EAST OF SECTION LINE FROM TOP OF RIDGE HEAD SOUTH AT WEST END)

NOTE: FENCE LINES ARE QUITE CROOKED & IN DILAPIDATED CONDITION

ALL TIES ARE P.K. NAILS WITH SHINERS, BLAZE ABOVE GROUND, INSCRIBED "B.T."
