PUBLIC LAND SURVEY MONUMENT RECORD

TYPE OF MONUMENT: HARRISON (BROKEN-TOP)
ADAMS COUNTY COORDINATES, NAD 83 (2007)

Survey Monument Record

CORNER NO. 100

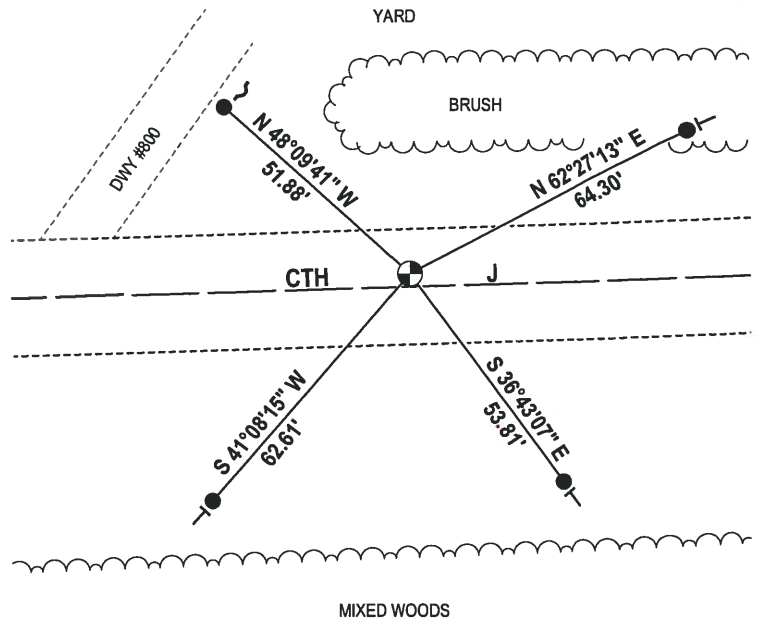
- TIE SKETCH -

2017 - PLS 2994 FOUND A HARRISON MONUMENT WITH A BROKEN-TOP 18" BELOW THE ROAD SURFACE. FOUND NO EVIDENCE OF ANY TIES OR WITNESSES. ACCEPTED THE HARRISON MONUMENT WITH A BROKEN-TOP AS THE BEST EVIDENCE OF THE CORNER LOCATION. SET 4 NEW TIES AND MEASURED TO THE TIES.

NOTE: THE CORNER FALLS 3'± NORTH OF THE CENTERLINE OF CTH AND 350'± EAST OF THE CENTERLINE OF 8TH AVE.

- 3/4" x 18" IRON REBAR SET, 1.50#/FT
- ⊕ HARRISON (BROKEN-TOP) FOUND
- ↙ SIGN FIRE #800
- VINYL "T" POST

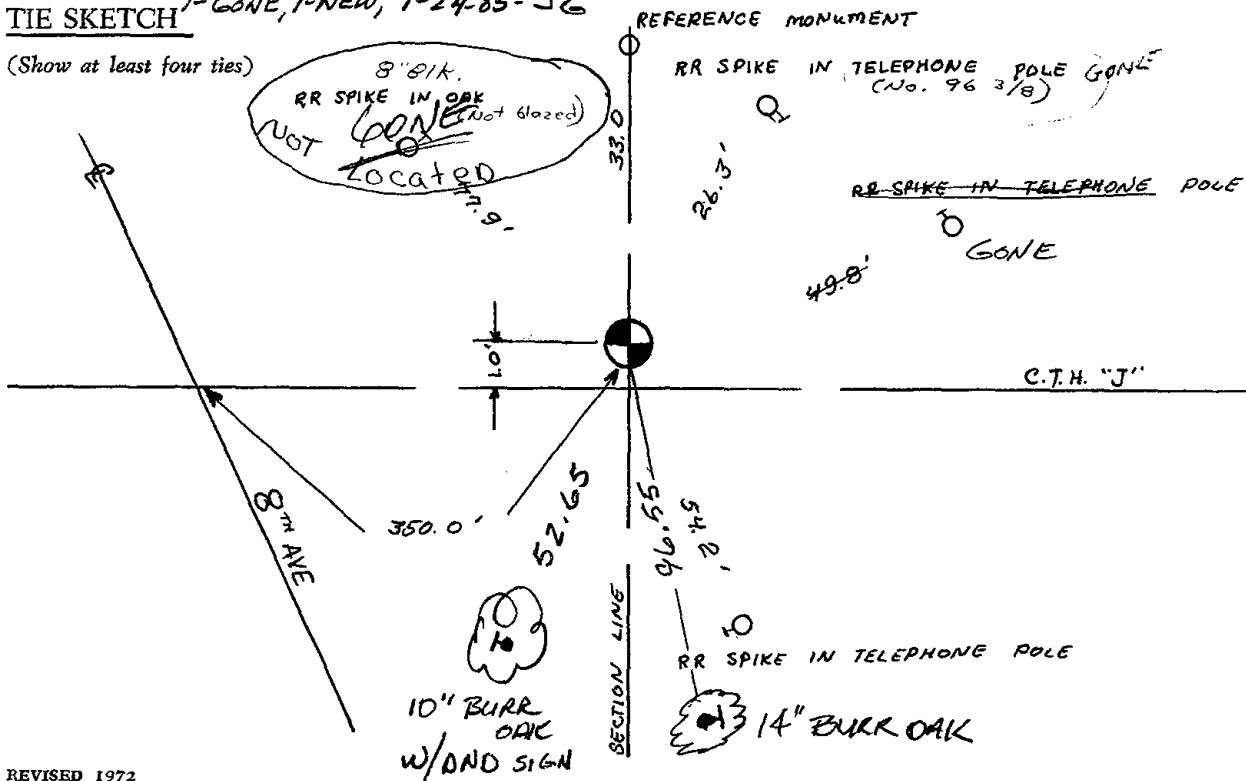
TIE SKETCH 1-GONE, 1-NEW, 1-24-05-JG

Harrison O.K. 9-20-75 S.J.S.
OK 1/23/80 RN-55

1 GONE NO NEW SS-DK

1 NEW 2-6-90 KZ-CR

ALL OK 7-29-94 JG-BS

ALL OK 1-6-00, JG
