PUBLIC LAND SURVEY MONUMENT RECORD

TYPE OF MONUMENT: HARRISON (BROKEN-TOP)

CORNER NO. 68

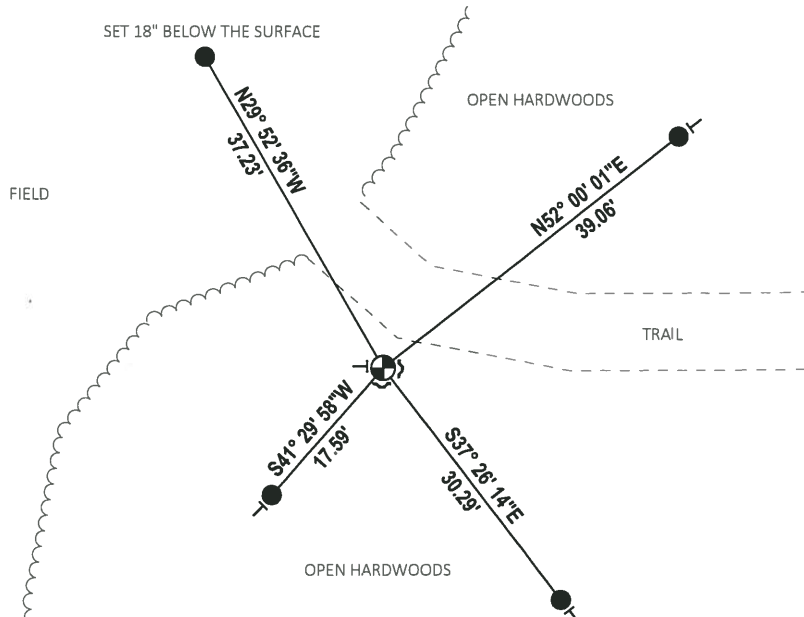
TIE SKETCH

2018 - PLS 2994 FOUND A HARRISON MONUMENT WITH A BROKEN-TOP 2" ABOVE THE GROUND SURFACE. FOUND NO EVIDENCE OF ANY OF THE EXISTING TIES OR WITNESSES. VERIFIED THE CORNER TO BE NEAR ON LINE AND EQUIDISTANT WITH THE SECTION CORNERS TO THE EAST AND WEST. ACCEPTED THE HARRISON MONUMENT WITH A BROKEN-TOP AS THE BEST EVIDENCE OF THE CORNER LOCATION. SET 4 NEW TIES AND MEASURED TO THE TIES.

NOTE: THE CORNER FALLS 7'± SOUTH OF THE CENTERLINE OF THE TRAIL.

- SET 3/4" x 18" IRON REBAR, 1.50#/FT
- ⊕ FOUND HARRISON MONUMENT (BROKEN-TOP)
- ↙ STEEL FENCE POST
- ← VINYL "T" POST

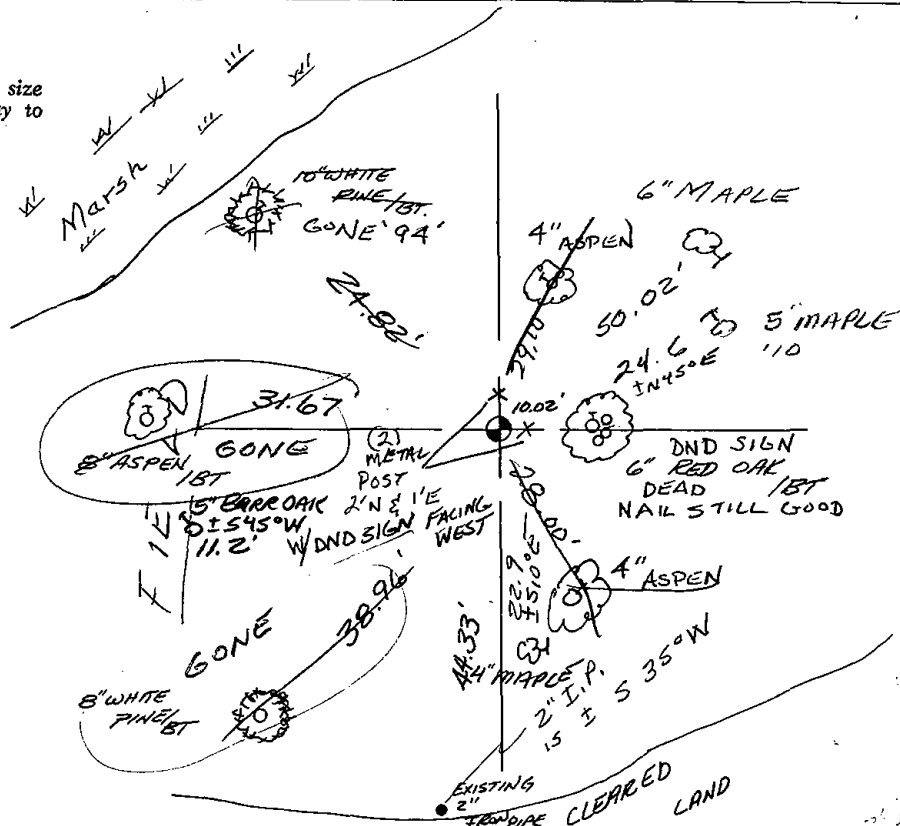
TIE SKETCH

Set Monument Equidistant and on line between adjacent section Corners.

No evidence of the post and bearings referred to by M.C. Smith in surveys of 12/21/12 and 12/19/07 was found.

1-GONE, 2-NEW 8-1-94 JG-RS TOP BROKEN OFF

ALL OK TOP BROKEN OFF, 4-6-00-JG

ALL OK 3-22-05 JG

3 NEW TIES 1-25-10-SS
