ADAMS COUNTY

COUNTY CORNER NO: 77
ROMPORTOL ID: 41706212000

PUBLIC LAND SURVEY MONUMENT RECORD

Government Land Corner Certificate

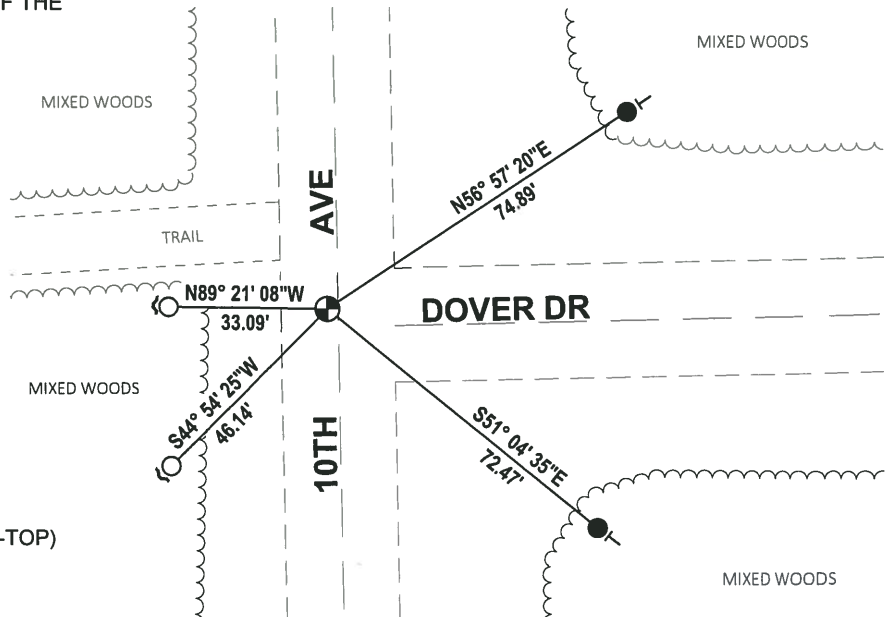
TIE SKETCH

2018 - PLS 2994 FOUND A HARRISON MONUMENT WITH A BROKEN-TOP 6" BELOW THE ROAD SURFACE, 1 TIE AND 1 PROPERTY IRON. THE MONUMENT AGREES WITH THE EXISTING TIE. ACCEPTED THE HARRISON MONUMENT WITH A BROKEN-TOP AS THE CORNER LOCATION. SET 2 NEW TIES AND MEASURED TO THE TIES AND PROPERTY IRON.

NOTE: THE CORNER FALLS 2± WEST OF THE CENTERLINE OF 10TH AVE AND 4± NORTH OF THE CENTERLINE OF DOVER DR.

- SET 3/4" x 18" IRON REBAR, 1.50#/FT
- FOUND 3/4" IRON ROD
- ⊙ FOUND HARRISON MONUMENT (BROKEN-TOP)
- ┘ STEEL FENCE POST
- └ VINYL "T" POST
