PUBLIC LAND SURVEY MONUMENT RECORD

TYPE OF MONUMENT: HARRISON (BROKEN-TOP)
 ADAMS COUNTY COORDINATES, NAD 83 (2007)

CORNER NO. 22
 SECTION 7
 TOWN 17
 RANGE 7

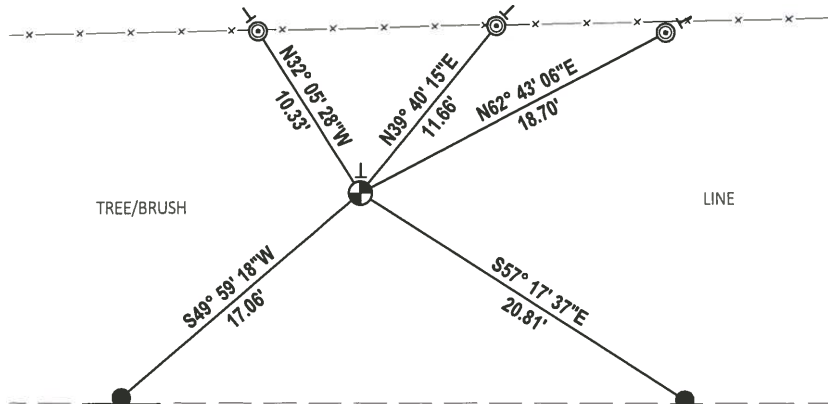
TIE SKETCH

2019 - PLS 2675 FOUND HARRISON (BROKEN-TOP) 8" BELOW THE GROUND AND 3 TIES. THE MONUMENT AGREES WITH ALL 3 TIES. ACCEPTED THE HARRISON (BROKEN-TOP) AS THE CORNER LOCATION. SET 2 NEW TIES AND MEASURED TO THE EXISTING TIES.

NOTE: CORNER FALLS 52"± SOUTH OF TRAIL.

NOTE: REBAR SET 24" BELOW THE GROUND SURFACE.

- SET 3/4" x 18" IRON REBAR, 1.50#/FT
- ⊙ FOUND 2-3/8" O.D. IRON PIPE
- ⊕ FOUND HARRISON (BROKEN-TOP) MONUMENT
- VINYL "T" POST

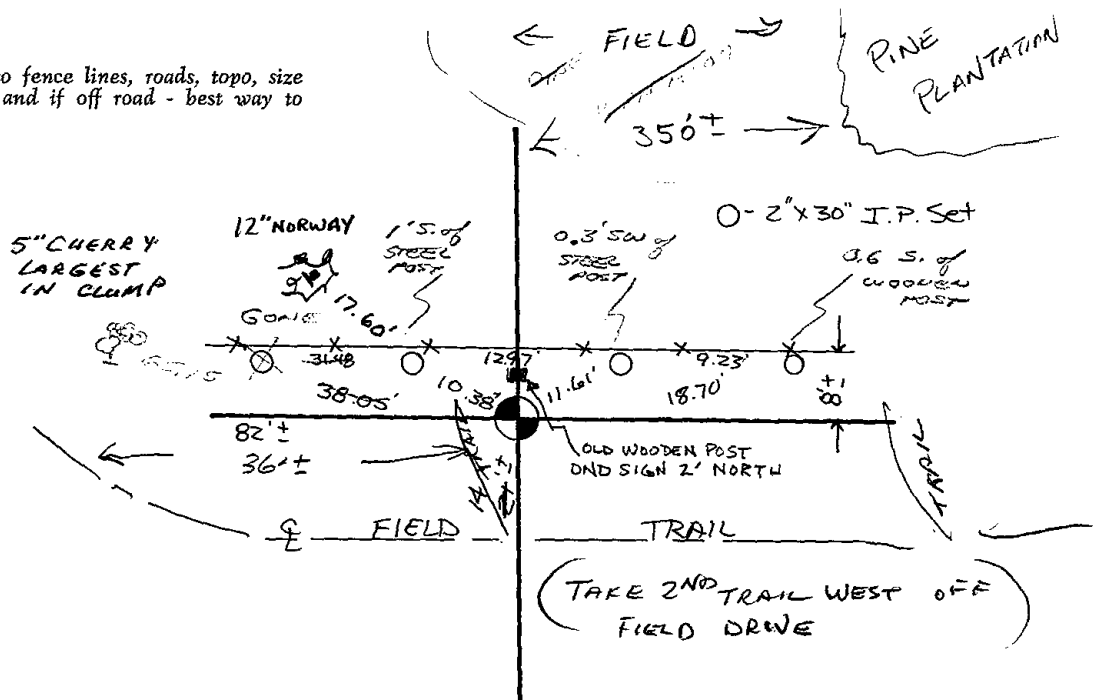
TIE SKETCH

This corner was set at single proportionate measure between section corners. No other evidence could be found for the location of this corner.
