# ADAMS COUNTY

COUNTY CORNER NO: 58

## PUBLIC LAND SURVEY MONUMENT RECORD

TYPE OF MONUMENT: HARRISON (BROKEN-TOP)  
ADAMS COUNTY COORDINATES, NAD 83 (2007)

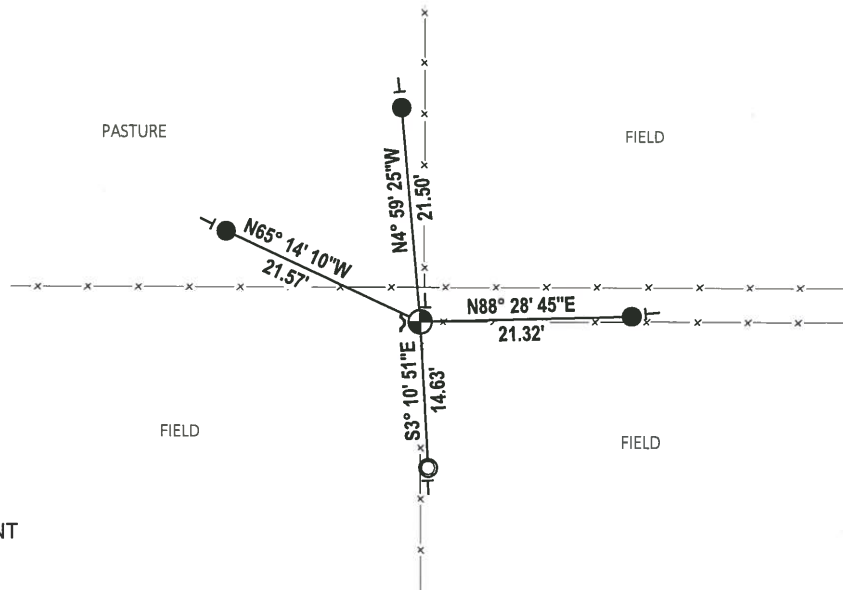
### TIE SKETCH

2019 - PLS 2675 FOUND HARRISON (BROKEN-TOP) 6" BELOW THE GROUND AND 1 TIE. THE MONUMENT AGREES WITH THE TIE. ACCEPTED THE HARRISON (BROKEN-TOP) AS THE CORNER LOCATION. SET 3 NEW TIES AND MEASURED TO THE EXISTING TIE.

- SET 3/4" x 18" IRON REBAR, 1.50#/FT
- FOUND 1-1/4" O.D. IRON PIPE
- ⊕ FOUND HARRISON (BROKEN-TOP) MONUMENT
- ┌ STEEL FENCE POST
- └ VINYL "T" POST

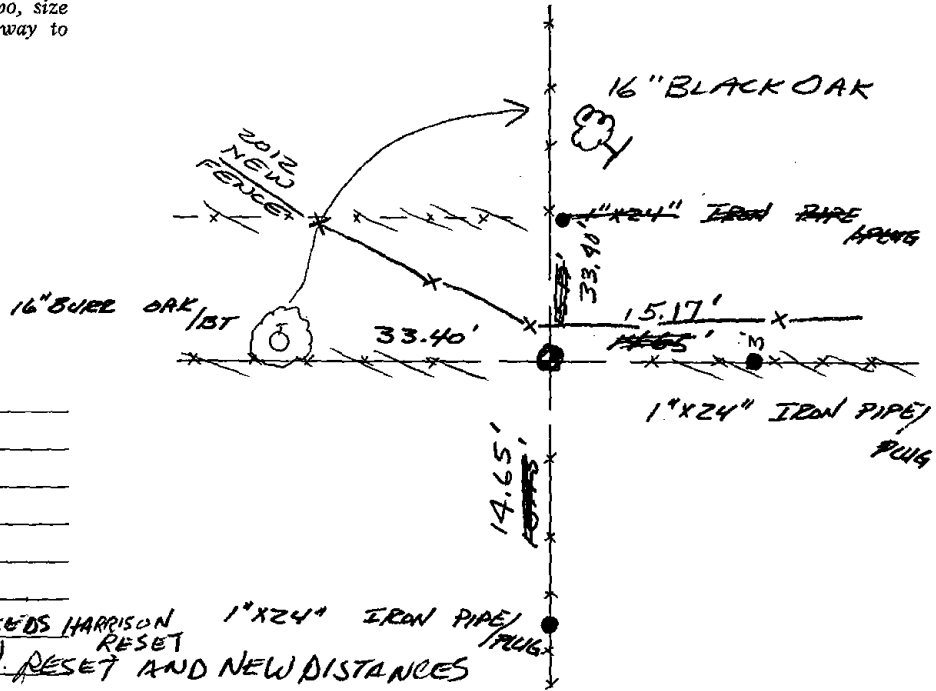
## TIE SKETCH

Ran EDM/T2 Traverse around sections 14 and 15 to determine search areas for investigation.

Could find no evidence of the original corner or any subsequent monumentation. Could find no bearing trees.

Well established fence corner is the best evidence of the location of the corner

Established corner at the fence corner.

Date	Init.	Remarks
6-11-82	PK-SS	O.K.
1-23-87	JL-SS	OK
7-27-92	JG	OK
1-29-97	JL-CR	OK
2-27-02	JG	FENCE POST GONE NEEDS HARRISON 1"X24" IRON PIPE/PLUG RESET
9-18-07	JG	HARRISON MON. RESET AND NEW DISTANCES
2-20-12	GR	OK
