## PUBLIC LAND SURVEY MONUMENT RECORD

TYPE OF MONUMENT: HARRISON (BROKEN-TOP)  
ADAMS COUNTY COORDINATES, NAD 83 (2007)

FIELD WORK DATE: 01/15/2018

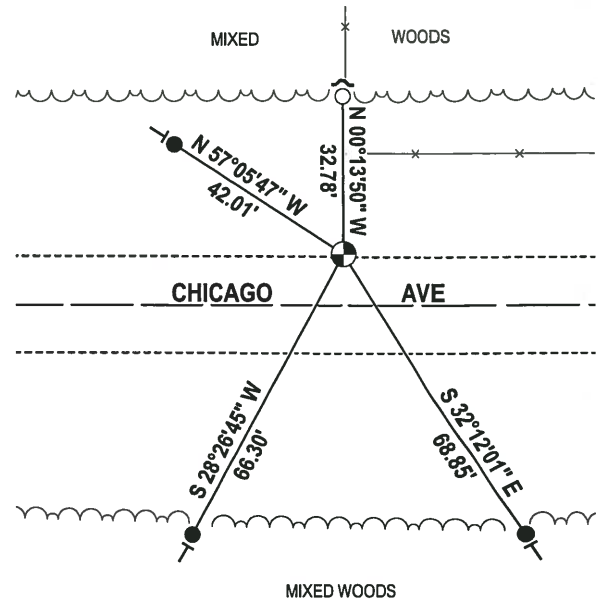
### - TIE SKETCH -

2018 - PLS 2994 FOUND A HARRISON MONUMENT WITH A BROKEN-TOP 2" BELOW THE GROUND SURFACE AND 1 TIE. THE MONUMENT AGREES WITH THE EXISTING TIE. ACCEPTED THE HARRISON MONUMENT WITH A BROKEN-TOP AS THE CORNER LOCATION. SET 3 NEW TIES AND MEASURED TO THE TIES.

NOTE: THE CORNER FALLS 10± NORTH OF THE CENTERLINE OF CHICAGO AVE AND 1± NORTH OF THE EDGE OF PAVEMENT.

- 3/4" x 18" IRON REBAR SET, 1.50#/FT
- 3/4" IRON ROD FOUND
- ⊕ HARRISON (BROKEN-TOP) FOUND
- ✓ STEEL FENCE POST
- └ VINYL "T" POST

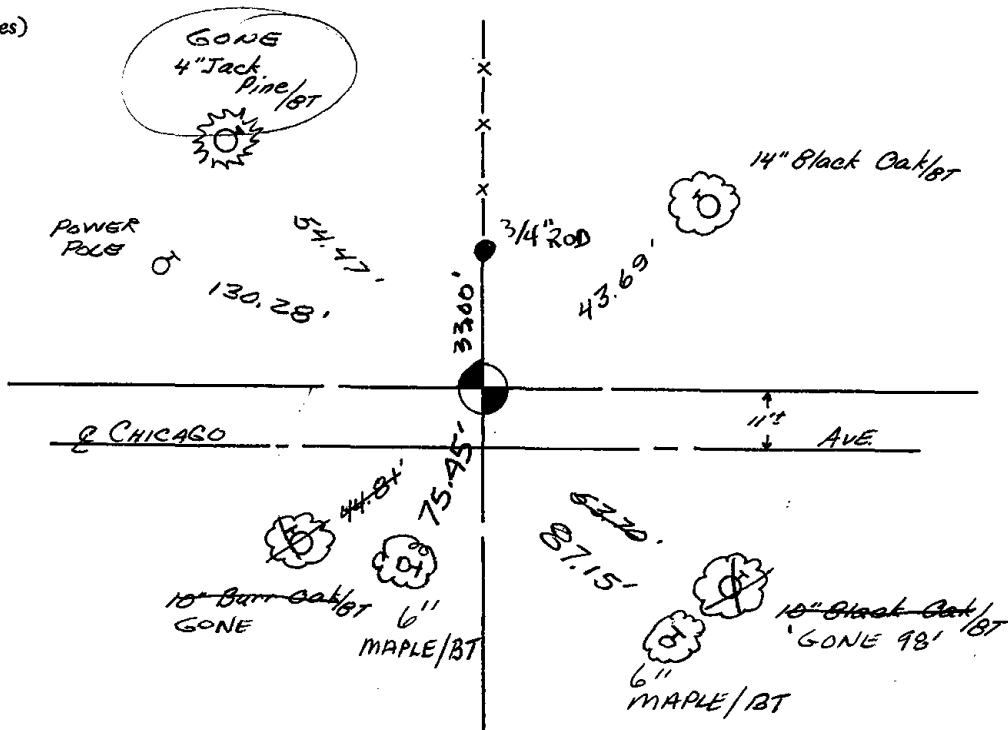
TIE SKETCH

Ran EDM/T2 traverse around Section 4 to determine search areas and to analyze ... possession. Dug opposite fence at N¼ corner and found nothing. Due to lack of evidence set N¼ corner opposite fence to North and on line between NW corner and NE corner of Section 4.

OK 7-28-78 RK-SS  
2-28-83 GR-SS 1 NEW TIE  
9-9-92 JG - OK  
2-GONE, 2-NEW, 2-9-98 - JG  
OK, 2-5-03-JG  
1-NEW, MON. OK, 12-18-07-JG
