PUBLIC LAND SURVEY MONUMENT RECORD

**U.S PUBLIC LAND SURVEY MONUMENT RECORD
ADAMS COUNTY, WISCONSIN**

CORNER NO. 15
SECTION 6
TOWN 18 N
RANGE 5 E

Government Land Corner Certificate

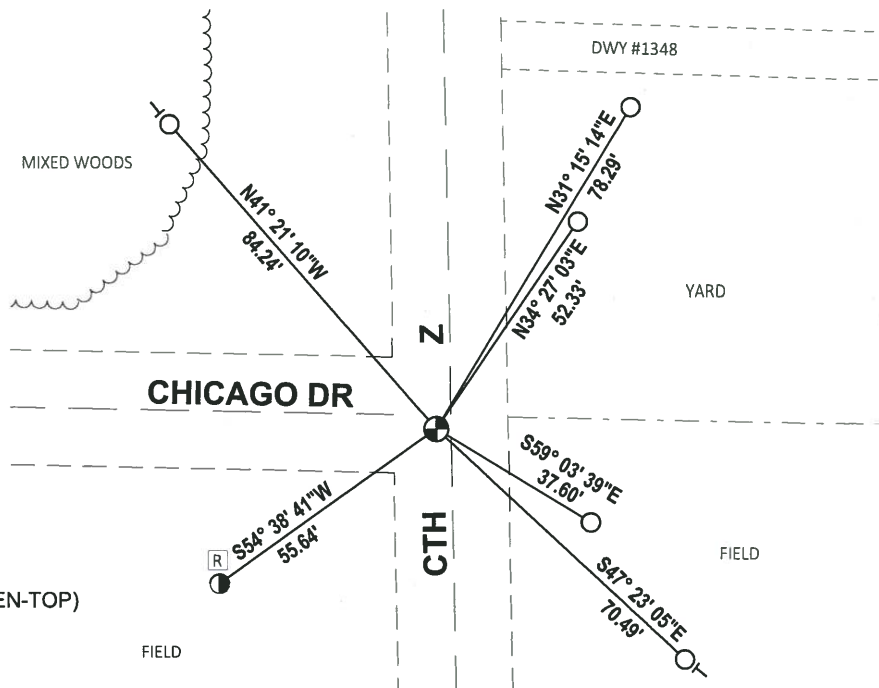
TIE SKETCH

2018 - PLS 2675 FOUND A 5" SPIKE IN THE ROAD SURFACE, 4 TIES AND 2 PROPERTY IRONS. REMOVED THE 5" SPIKE AND FOUND A HARRISON MONUMENT WITH A BROKEN-TOP 18" BELOW THE ROAD SURFACE. THE MONUMENT AGREES WITH THE EXISTING TIES. ACCEPTED THE HARRISON MONUMENT WITH A BROKEN-TOP AS THE CORNER LOCATION AND RE-MEASURED TO THE EXISTING TIES AND PROPERTY IRONS.

NOTE: THE CORNER FALLS 3± SOUTH OF THE CENTERLINE OF CHICAGO AVE AND 3± WEST OF THE CENTERLINE OF CTH Z.

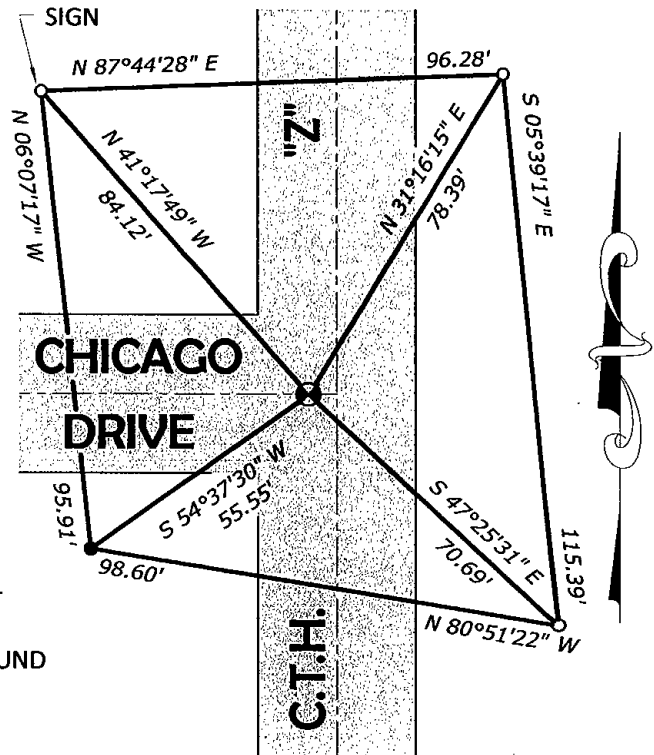
TIE SKETCH: No Scale

On April 13, 1981 Anthony B. Kiedrowski found a dark squared stain 3" x 8" in a circular area of disturbed soil and set a Harrison monument. Corner was buried 1.5' under the surface so I set a 5" galvanized landscaping spike over the top of the monument.

- 3/4" IRON ROD SET
- 5/8" IRON ROD FOUND AT RW POST

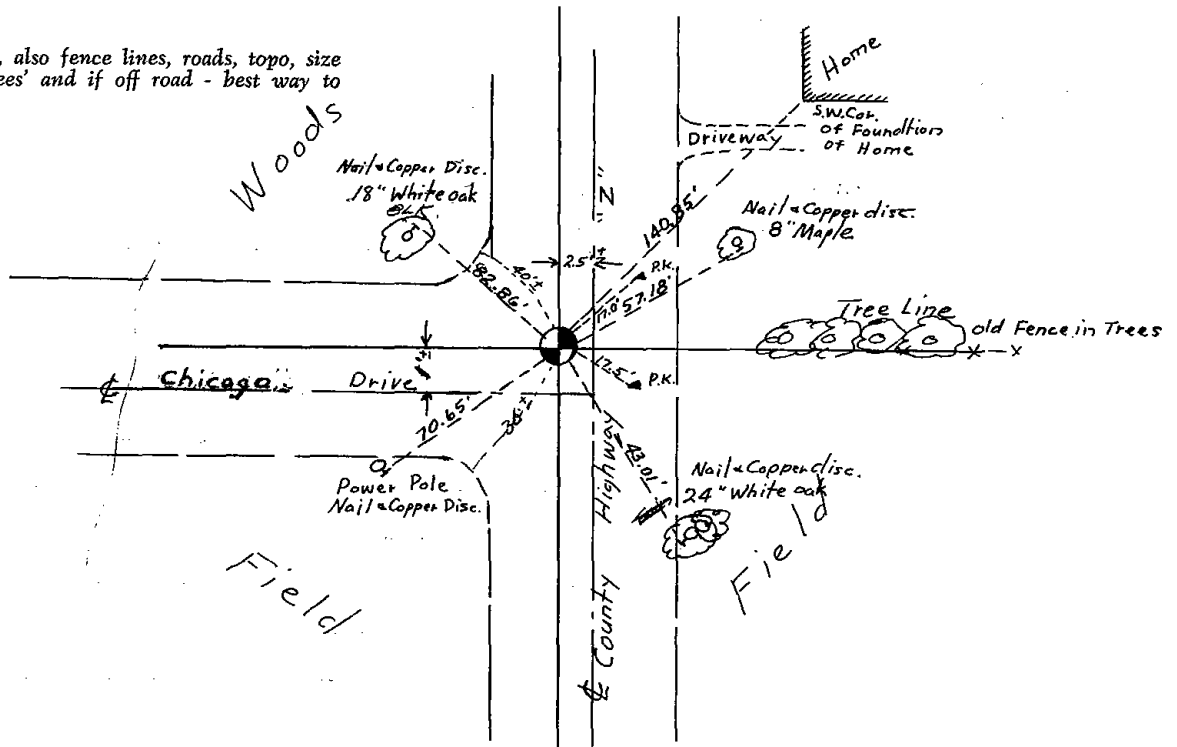
TIE SKETCH

No record of any resurveys. Excavated with backhoe, found ~~nothing. Corner is not set on a straight line, as this would not match any forty line occupation. Location of this corner~~ dark squared stain, 3" x 8" in a circular area of disturbed soil. It appeared as though there was a stone at this location at one time. Since we also found a stone at the west ¼ corner of this section, the stain was monumented and the location verified by EDM traverse.

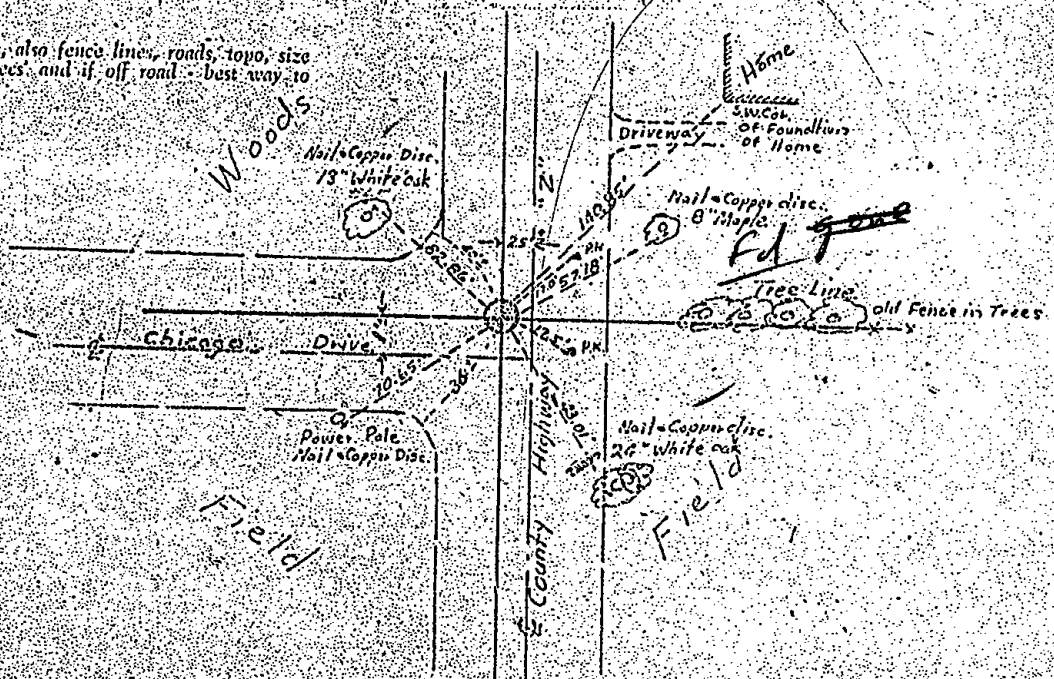
TIE SKETCH

No record of any resurveys. Excavated with backhoe, found nothing. Corner is not set on a straight line, as this would not match any forty-line-occupation. Location of this corner dark squared stain, 3" x 8" in a circular area of disturbed soil. It appeared as though there was a stone at this location at one time. Since we also found a stone at the west 1/4 corner of this section, the stain was monumented and the location verified by EDM traverse.

6-26-91 MC Ties OK
