26 SECTION 18 TOWN 05 RANGE

ADAMS COUNTY

COUNTY CORNER NO: 99
ROMPORTOL ID: 41805262000

PUBLIC LAND SURVEY MONUMENT RECORD

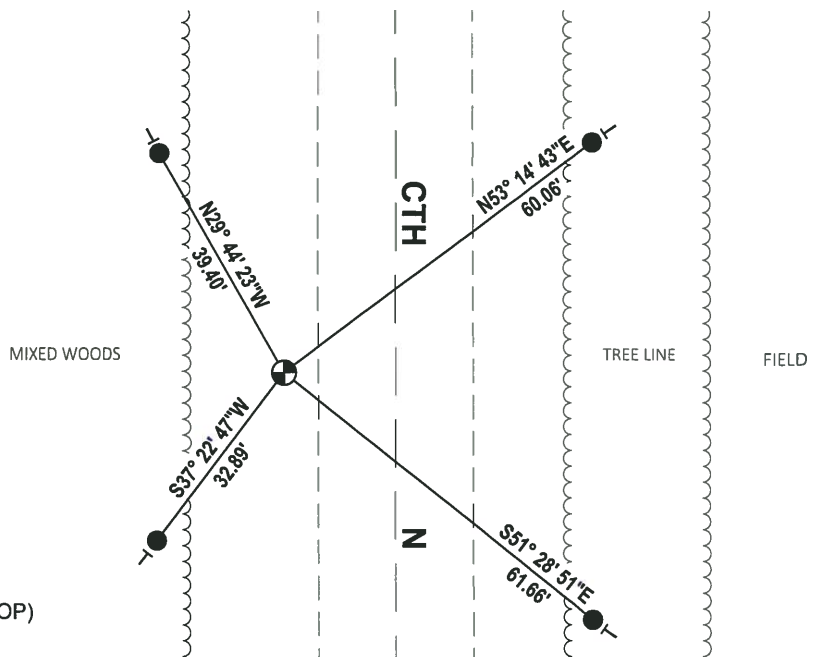
- TIE SKETCH

2018 - PLS 2675 FOUND A HARRISON MONUMENT WITH A BROKEN-TOP 24" BELOW THE GROUND SURFACE. FOUND NO EVIDENCE OF ANY OF THE EXISTING TIES OR WITNESSES. ACCEPTED THE HARRISON MONUMENT WITH A BROKEN-TOP AS THE BEST EVIDENCE OF THE CORNER LOCATION. AFTER REVIEW THE CORNER FALLS NEAR EQUIDISTANT AND ON LINE. SET 4 NEW TIES AND MEASURED TO THE TIES.

NOTE: THE CORNER FALLS 17'± WEST OF THE CENTERLINE OF CTH N.

- SET 3/4" x 18" IRON REBAR, 1.50#/FT
- ⊕ FOUND HARRISON MONUMENT (BROKEN-TOP)
- VINYL "T" POST

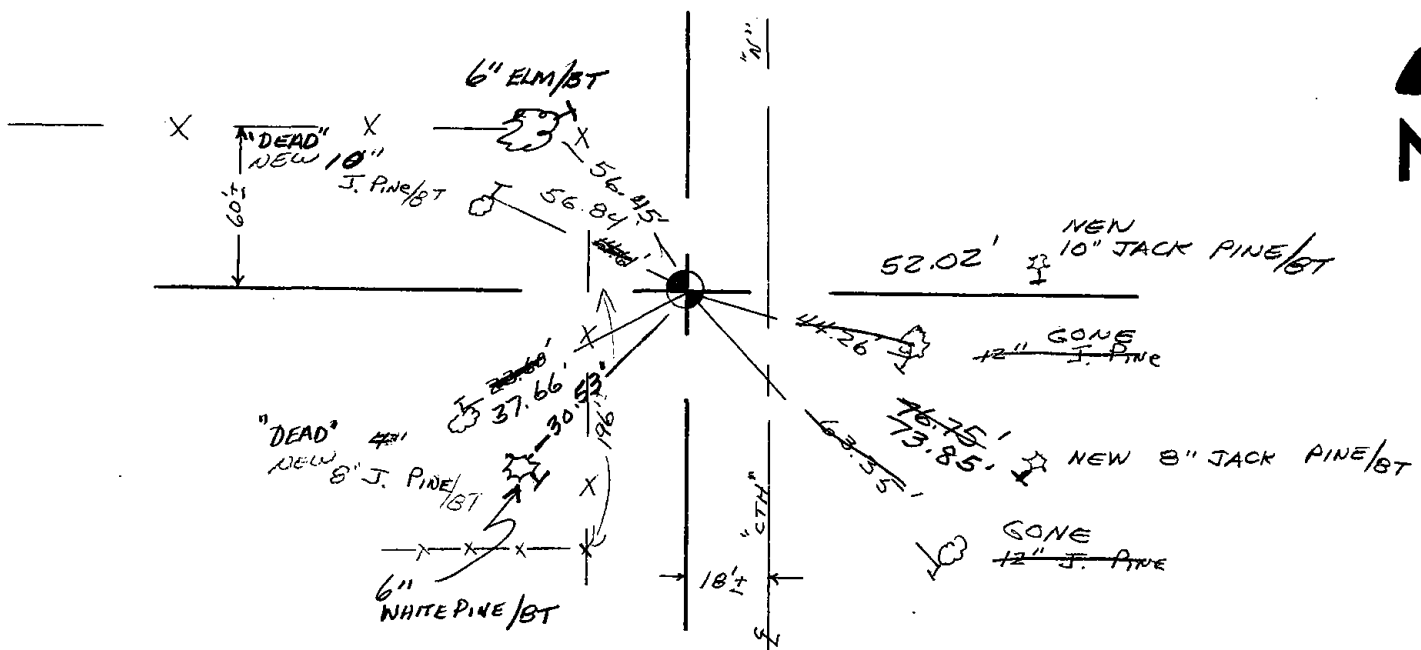
TIE SKETCH OK, 12-11-07, SG-SS All ties to nail and disc.

Excavated area with backhoe opposite fence line. Found no evidence. Point established on line and equi-distant between section corners.

TOP BROKEN - BOTTOM IN PLACE - 2 NEW TIES
3-1-83 GR-SS

1 - GONE 1 - NEW, 2-3-98 - JG
2 - NEW, 5-1-03 - JG
