35 SECTION    19 TOWN    06 RANGE

# ADAMS COUNTY

COUNTY CORNER NO: 131  
 ROMPORTOL ID: 41906350000

## PUBLIC LAND SURVEY MONUMENT RECORD

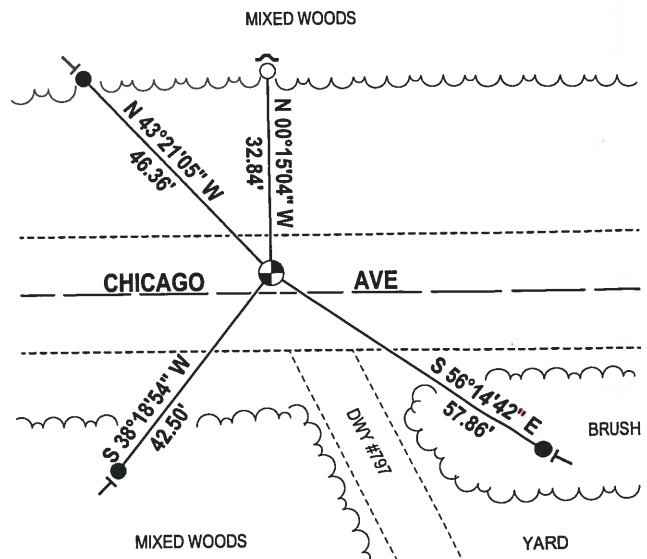
### - TIE SKETCH

2018 - PLS 2994 FOUND A HARRISON MONUMENT WITH A BROKEN-TOP 12" BELOW THE ROAD SURFACE AND 1 TIE. THE MONUMENT AGREES WITH THE EXISTING TIE. ACCEPTED THE HARRISON MONUMENT WITH A BROKEN-TOP AS THE CORNER LOCATION. SET 3 NEW TIES AND MEASURED TO THE TIES.

NOTE: THE CORNER FALLS 4± NORTH OF THE CENTERLINE OF CHICAGO AVE.

- 3/4" x 18" IRON REBAR SET, 1.50#/FT
- 3/4" IRON ROD FOUND
- ⊕ HARRISON (BROKEN-TOP) FOUND
- ↗ STEEL FENCE POST
- VINYL "T" POST

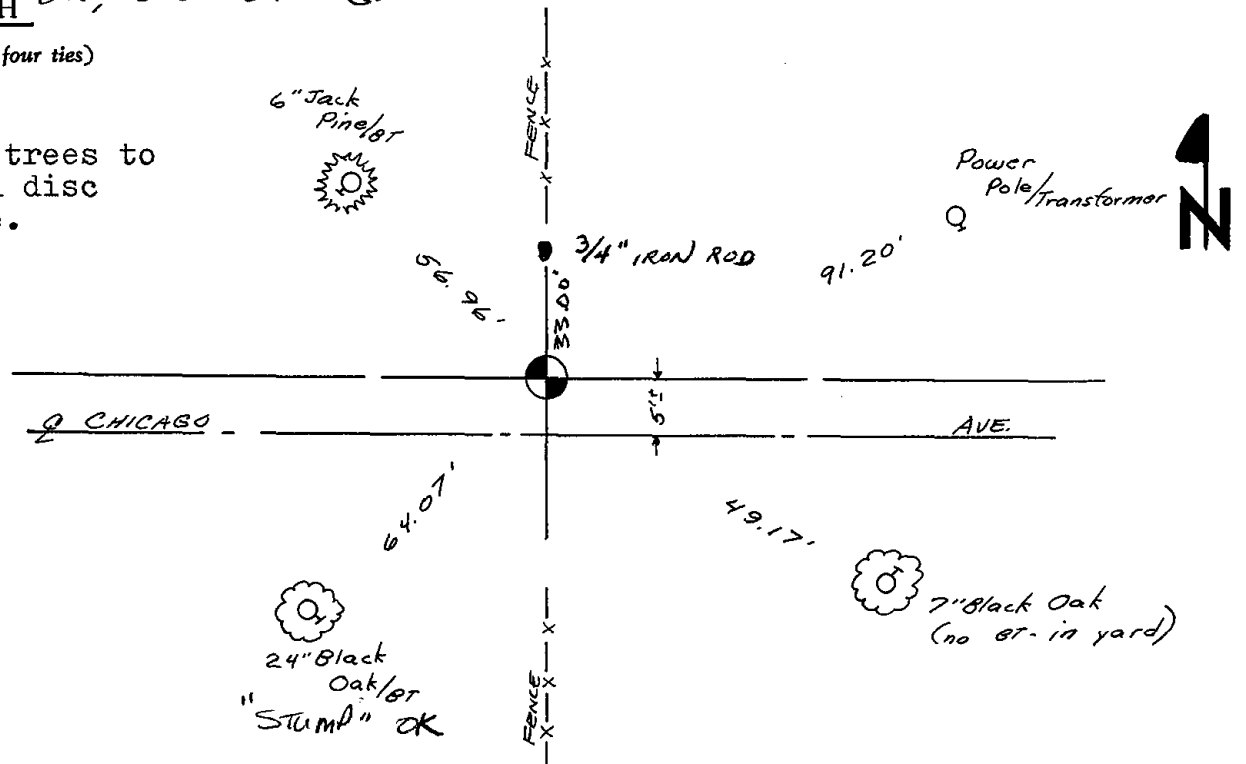
### TIE SKETCH OK, 12-20-07- JG-SS

Ran EDM/transit traverse around Sections 1 and 12, and portions of adjoining sections to determine search areas for investigation.

Excavation with backhoe yielded no evidence of the original corner or any remonumentation.

Set corner by doubling over line between the Northwest and North Quarter corner of Section 2.

Ties in trees to nail and disc in blaze.
