ADAMS COUNTY COUNTY COUNTY CORNER NO: 72

ROMPORTOL ID: 41806130020

PUBLIC LAND SURVEY MONUMENT RECORD

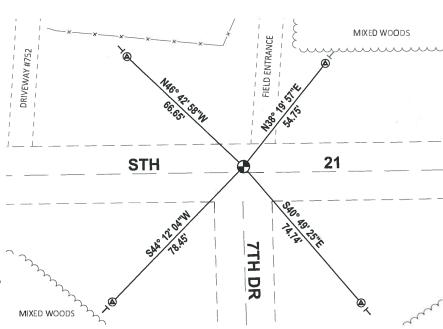
- TIE SKETCH

2019 - PLS 2675 FOUND SURVEY NAIL IN THE ROAD SURFACE, REMOVED AND DID NOT FIND ANY EVIDENCE OF ANY ADDITIONAL MONUMENTS BELOW AND 4 TIES. THE SURVEY NAIL LOCATION AGREES WITH THE EXISTING TIES. ACCEPTED THE SURVEY NAIL AS LOCATION AS THE CORNER LOCATION. RESET A SURVEY NAIL IN THE CORNER LOCATION AND MEASURED TO THE EXISTING TIES.

NOTE: THE CORNER FALLS 2.5'± NORTH OF THE CENTERLINE OF STH 21.

FOUND BERNTSEN SSDR103 W/BRONZE CAP

FOUND SURVEY NAIL MONUMENT

VINYL "T" POST
