26 SECTION

O6 RANGE ADAMS COUNTY CORNER NO: 110 ROMPORTOL ID: 41806260020

PUBLIC LAND SURVEY MONUMENT RECORD

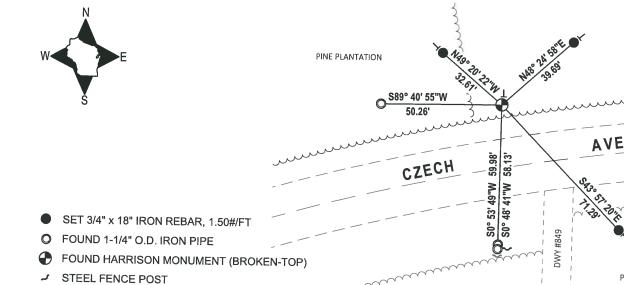
-TIE SKETCH

2019 - PLS 2675 FOUND A HARRISON MONUMENT WITH A BROKEN-TOP 6" BELOW THE GROUND SURFACE, 2 TIES AND 1 PROPERTY IRON. THE MONUMENT AGREES WITH THE EXISTING TIES. ACCEPTED THE HARRISON MONUMENT WITH A BROKEN-TOP AS THE CORNER LOCATION. SET 3 NEW TIES AND MEASURED TO THE TIES AND PROPERTY IRON.

NOTE: THE CORNER FALLS 26'± NORTH OF THE CENTERLINE OF CZECH AVE.

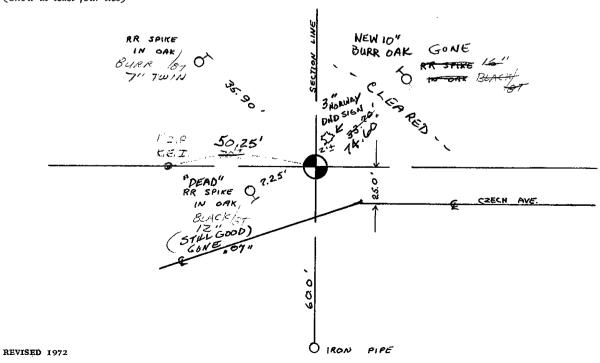
TIE SKETCH

Set by Sam Mullen.
