ADAMS COUNTY COUNTY CORNER NO: 75

PUBLIC LAND SURVEY MONUMENT RECORD

CORNER NO. 75 SECTION 20 TOWN 19 N RANGE 5 E

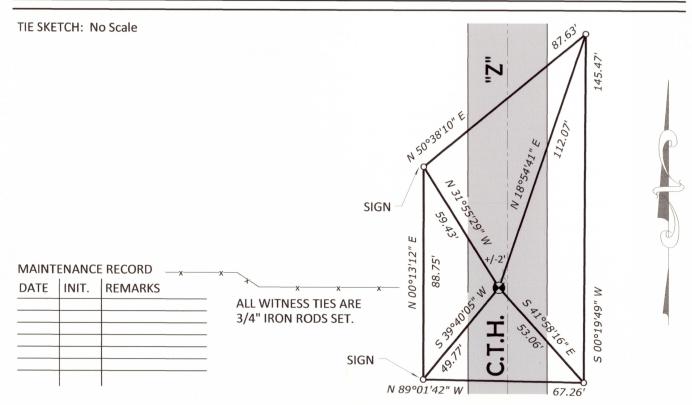
-TIE SKETCH

NOTE: THE CORNER LANDS 2'± WEST OF CENTERLINE OF CTH "Z"

O FOUND 3/4" IRON ROD

FOUND HARRISON (BROKEN-TOP) MONUMENT

→ VINYL "T" POST
