PUBLIC LAND SURVEY MONUMENT RECORD

TYPE OF MONUMENT: HARRISON
 ADAMS COUNTY COORDINATES, NAD 83 (2005)

ADAMS COUNTY

Survey Monument Record

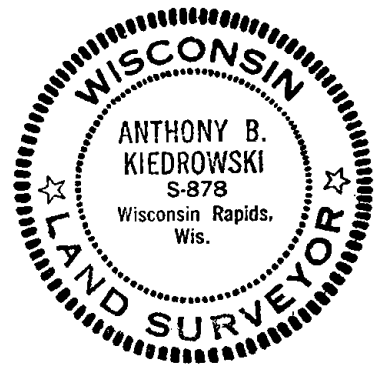
- OK 1-28-09 SS-MS
- OK 1-5-04-JG
- OK 1-25-99-JG
- 3 NEW TIES 2-25-74 CR-JG
- OK 3-20-79 RN-SS

Ok 3-21-84 SS

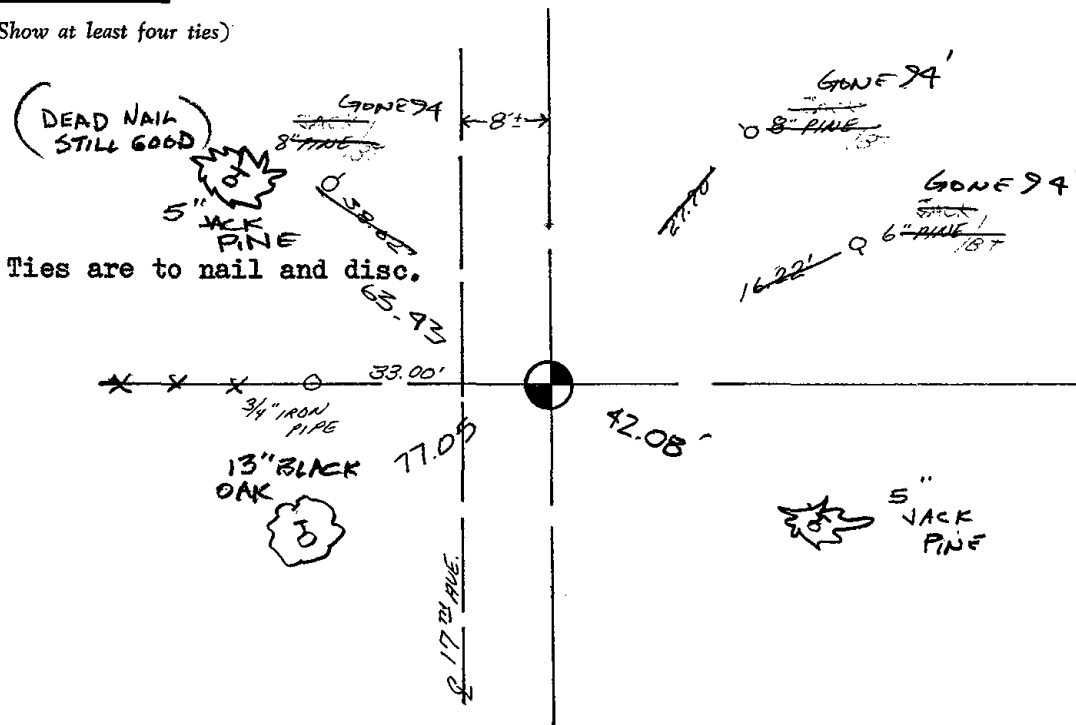
TIE SKETCH

Set $\frac{1}{4}$ corner 33 feet east of 1" iron pipe found. Excavated all the way across the dirt road with a backhoe but found nothing. I could not justify putting this corner on a straight line between section corners, as this would have put it more than 100' off the road to the east. The area was thoroughly searched but could find no other evidence.

MONUMENT $\pm 10'$ BELOW ROAD SURFACE
