PUBLIC LAND SURVEY MONUMENT RECORD

TYPE OF MONUMENT: HARRISON
 ADAMS COUNTY COORDINATES, NAD 83 (2005)

ADAMS COUNTY

Survey Monument Record

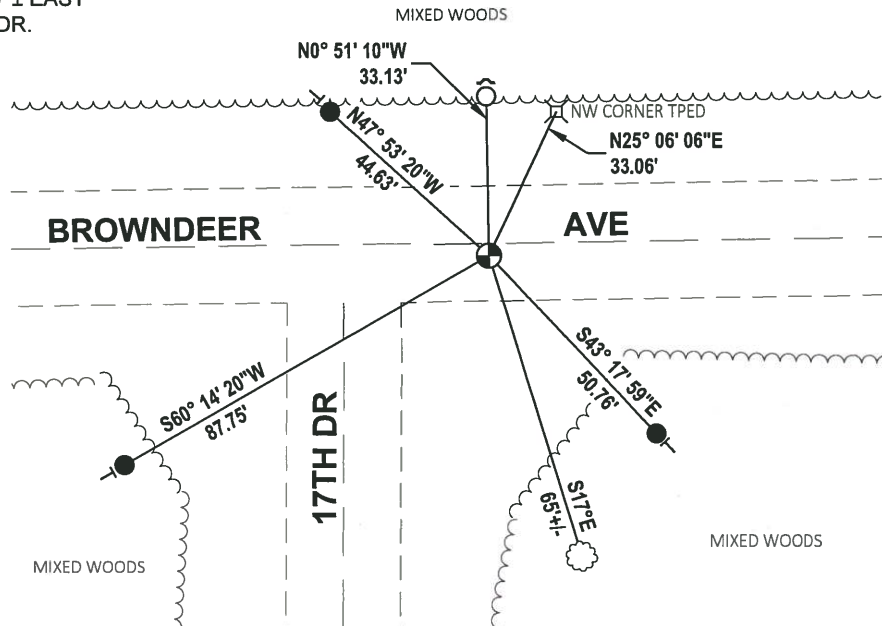
-TIE SKETCH

2019 - PLS 2675 FOUND A HARRISON MONUMENT 10" BELOW THE ROAD SURFACE, 2 WITNESSES AND 1 PROPERTY IRON. THE MONUMENT AGREES WITH THE EXISTING WITNESSES. ACCEPTED THE HARRISON MONUMENT AS THE CORNER LOCATION. SET 3 NEW TIES AND MEASURED TO THE TIES, PROPERTY IRON AND WITNESSES.

NOTE: THE CORNER FALLS 3' ± SOUTH OF THE CENTERLINE OF BROWNDEER AVE AND 30' ± EAST OF THE EXTENDED CENTERLINE OF 17TH DR.

- SET 3/4" x 18" IRON REBAR, 1.50#/FT
- FOUND 3/4" IRON ROD
- ⊕ FOUND HARRISON MONUMENT
- ~ STEEL FENCE POST
- VINYL "T" POST
- ⊗ WITNESS TREE

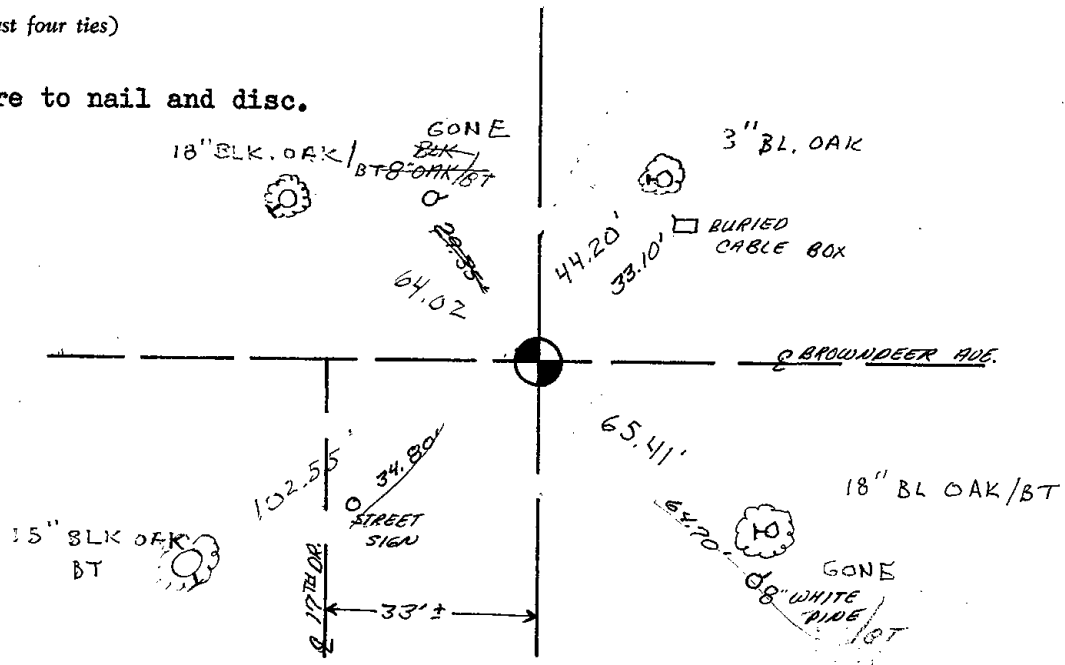
TIE SKETCH

Excavated area of road intersection with backhoe. Found nothing. This point set equidistant but not on a straight line between section corners. After running the quarter line north from here $\frac{1}{2}$ mile, we fell right on an old center of section fence intersection. Concluded that the road running south from here did not center on the quarter line.

Ties are to nail and disc.
