32 SECTION 19 TOWN 05 RANGE

COUNTY CORNER NO: 124
ROMPORTOL ID: 41905320020

PUBLIC LAND SURVEY MONUMENT RECORD

Survey Monument Record

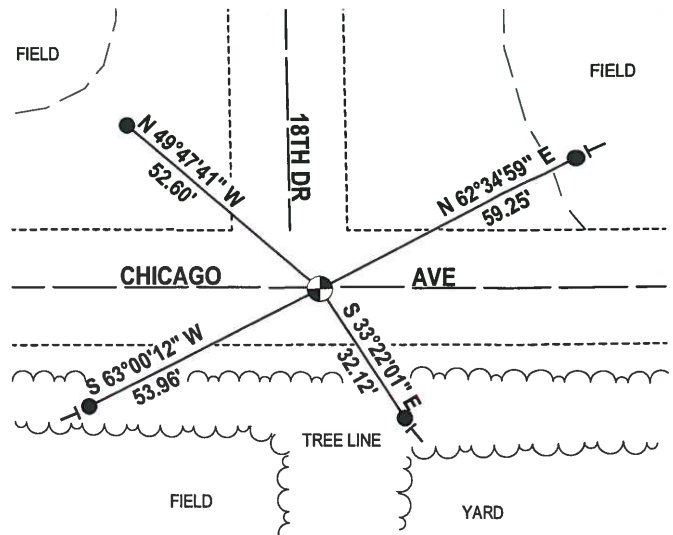
- TIE SKETCH -

2018 - PLS 2994 FOUND A HARRISON MONUMENT WITH A BROKEN-TOP 12" BELOW THE ROAD SURFACE. FOUND NO EVIDENCE OF ANY OF THE WITNESSES. ACCEPTED THE HARRISON MONUMENT WITH A BROKEN-TOP AS THE BEST EVIDENCE OF THE CORNER LOCATION. SET 4 NEW TIES AND MEASURED TO THE TIES.

NOTE: THE CORNER FALLS 0.5'± SOUTH OF THE CENTERLINE OF CHICAGO AVE AND 6'± EAST OF THE CENTERLINE OF 18TH DR.

- 3/4" x 18" IRON REBAR SET, 1.50#/FT
- ⊕ HARRISON (BROKEN-TOP) FOUND
- VINYL "T" POST

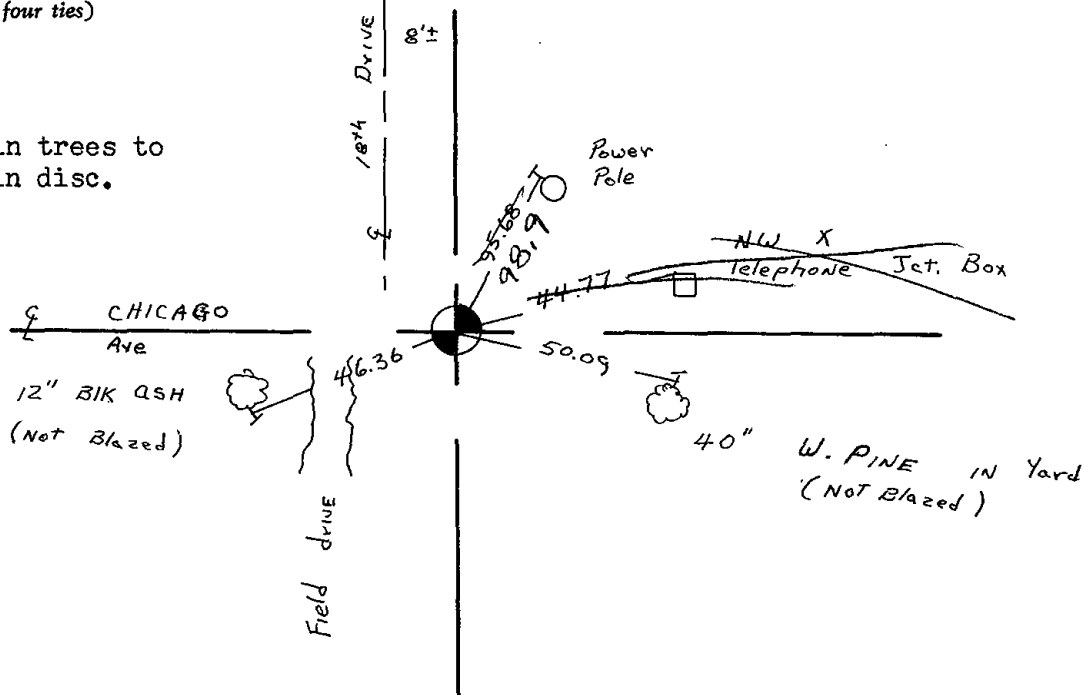
TIE SKETCH *OK 12-22-03-JG*
3 TIES REMAIN 4-7-09 SS

Excavated with backhoe but found no evidence of the South Quarter corner of Section 32.

Ran EDM/transit traverse around Section 32 and set Quarter corner equidistant and on line between Southeast and Southwest section corners.

Ties in trees to nail in disc.
