PUBLIC LAND SURVEY MONUMENT RECORD

TYPE OF MONUMENT: HARRISON (BROKEN-TOP)
 ADAMS COUNTY COORDINATES, NAD 83 (2007)

ADAMS COUNTY

Survey Monument Record

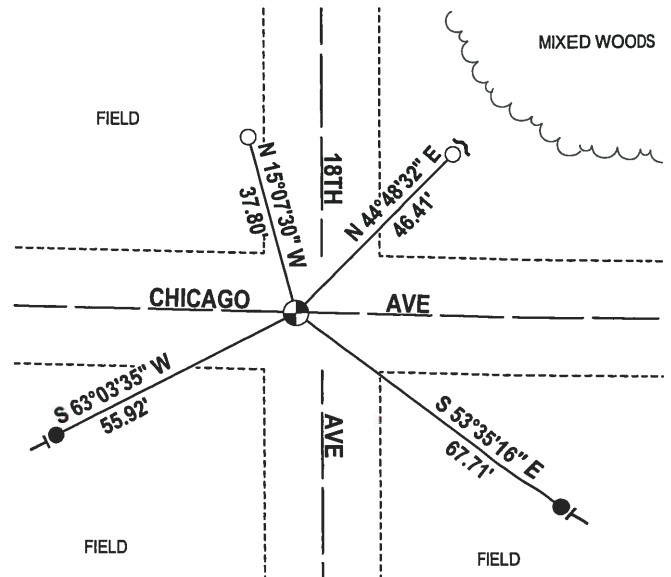
- TIE SKETCH

2018 - PLS 2994 FOUND A HARRISON MONUMENT WITH A BROKEN-TOP 8" BELOW THE ROAD SURFACE, 1 TIE AND 1 PROPERTY IRON. THE MONUMENT AGREES WITH THE EXISTING TIE. ACCEPTED THE HARRISON MONUMENT WITH A BROKEN-TOP AS THE CORNER LOCATION. SET 2 NEW TIES AND MEASURED TO THE TIES AND PROPERTY IRON.

NOTE: THE CORNER FALLS 5± WEST OF THE CENTERLINE OF 18TH AVE.

- 3/4" x 18" IRON REBAR SET, 1.50#/FT
- 3/4" IRON ROD FOUND
- ⊕ HARRISON (BROKEN-TOP) FOUND
- ↗ STEEL FENCE POST
- VINYL "T" POST

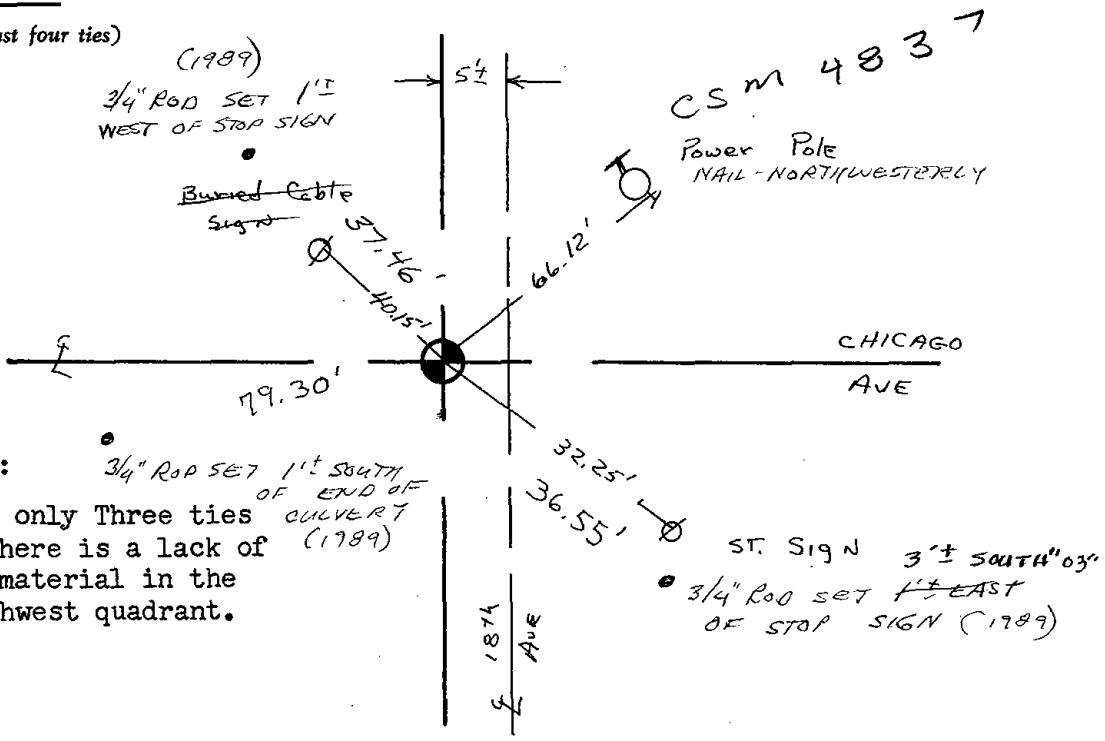
TIE SKETCH 1-14-09SS

3 NEW TIES 7-7-89 SS-MK
OK 12-22-03-JG

NOTE: 3/4" Rod set 1' SOUTH OF END OF CULVERT (1989)
Took only Three ties as there is a lack of tie material in the Southwest quadrant.
