ADAMS COUNTY

COUNTY CORNER NO: 128
ROMPORTOL ID: 42006340020

PUBLIC LAND SURVEY MONUMENT RECORD

Government Land Corner Certificate

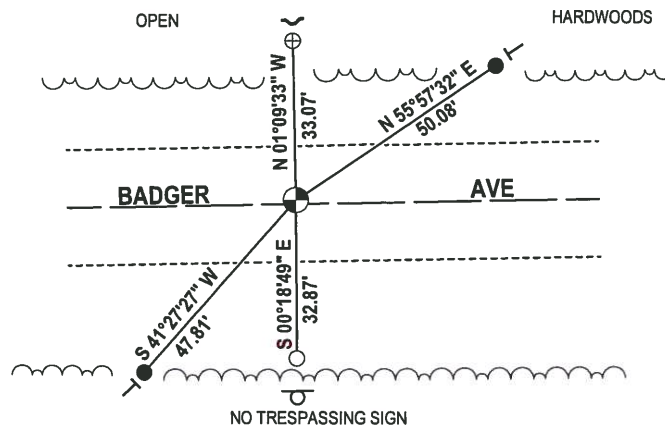
- TIE SKETCH

2018 - PLS 2994 FOUND A HARRISON MONUMENT WITH A BROKEN-TOP 8" BELOW THE ROAD SURFACE AND 2 TIES. THE MONUMENT AGREES WITH THE EXISTING TIES. ACCEPTED THE HARRISON MONUMENT WITH A BROKEN-TOP AS THE CORNER LOCATION. SET 2 NEW TIES AND MEASURED TO THE TIES.

NOTE: THE CORNER FALLS 1 1/2" NORTH OF THE CENTERLINE OF BADGER AVE.

- 1.0" O.D. IRON PIPE FOUND
- ⊕ 2-3/8" O.D. IRON PIPE FOUND
- 3/4" x 18" IRON REBAR SET, 1.50#/FT
- ⊕ HARRISON (BROKEN-TOP) FOUND
- └ VINYL "T" POST
- ┌ EXISTING STEEL FENCE POST

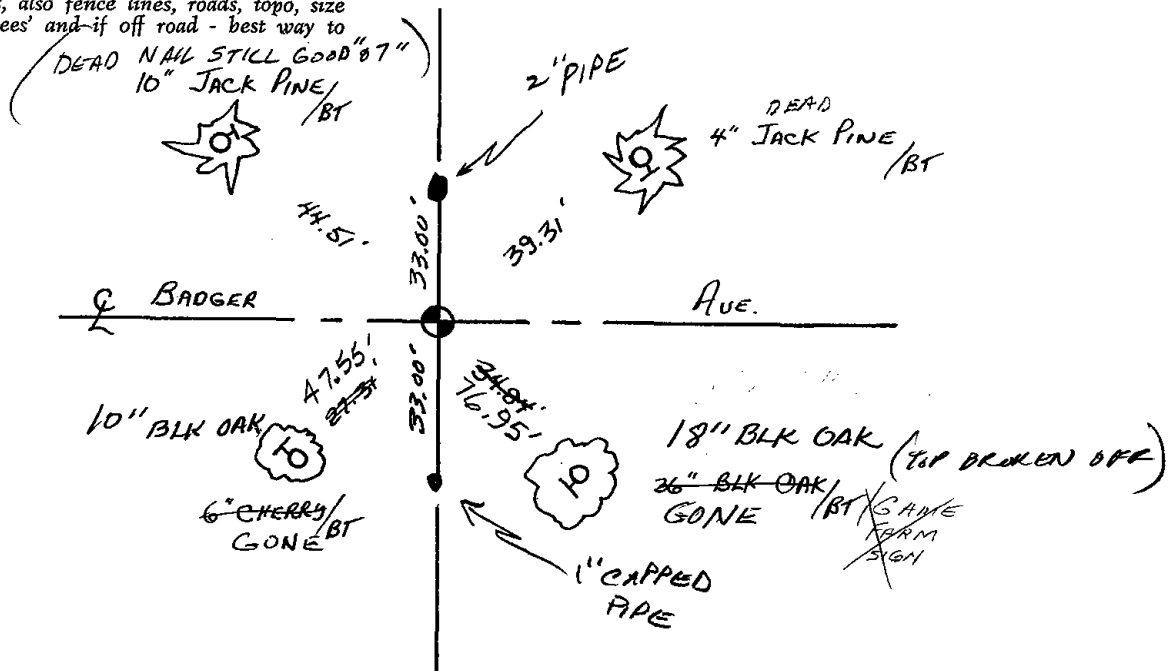
TIE SKETCH

Excavated area with backhoe. Found nothing. Corner set on line equidistant between section corners. No resurveys on record and absolutely no evidence of possession lines in area.
