ADAMS COUNTY

COUNTY CORNER NO: 37

PUBLIC LAND SURVEY MONUMENT RECORD

TYPE OF MONUMENT: HARRISON (BROKEN-TOP)
ADAMS COUNTY COORDINATES, NAD 83 (2007)

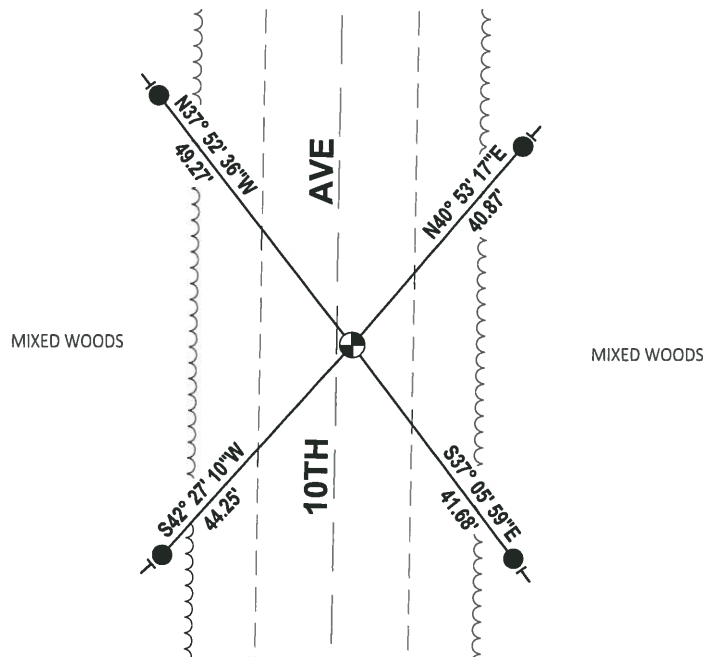
TIE SKETCH

NOTE: THE CORNER FALLS 2'± EAST OF THE CENTERLINE OF 10TH AVE AND 75'± SOUTH OF THE CENTERLINE OF DWY #845.

- SET 3/4" x 18" IRON REBAR, 1.50#/FT
- ⊕ FOUND HARRISON MONUMENT (BROKEN-TOP)
- VINYL "T" POST

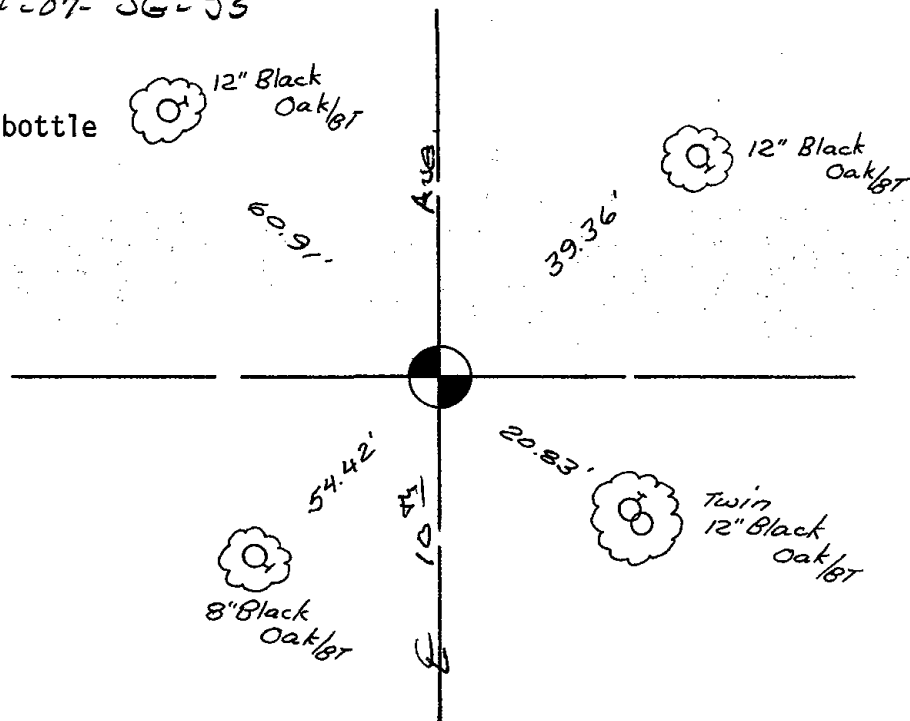
TIE SKETCH

Did not excavate . Could not determine just where to dig. Corner set half way between section corners, but not on line. There is a considerable P.I. at this point. No resurveys on record.

Ties are to nail and bottle cap.
