ADAMS COUNTY

COUNTY CORNER NO: 47

PUBLIC LAND SURVEY MONUMENT RECORD

Government Land Corner Certificate

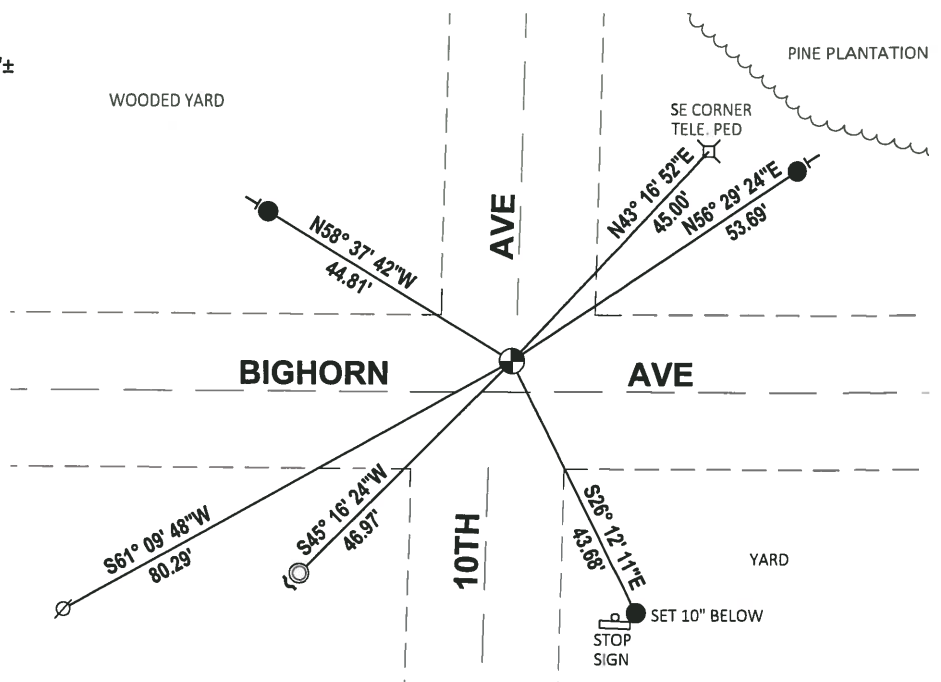
TIE SKETCH

NOTE: THE CORNER FALLS 5± NORTH OF THE CENTERLINE OF BIGHORN AVE AND 1± EAST OF THE CENTERLINE OF 10TH AVE.

- SET 3/4" x 18" IRON REBAR, 1.50#/FT
- FOUND 1-1/4" O.D. IRON PIPE
- FOUND HARRISON MONUMENT
- WITNESS POWER POLE
- ✓ STEEL FENCE POST
- VINYL "T" POST

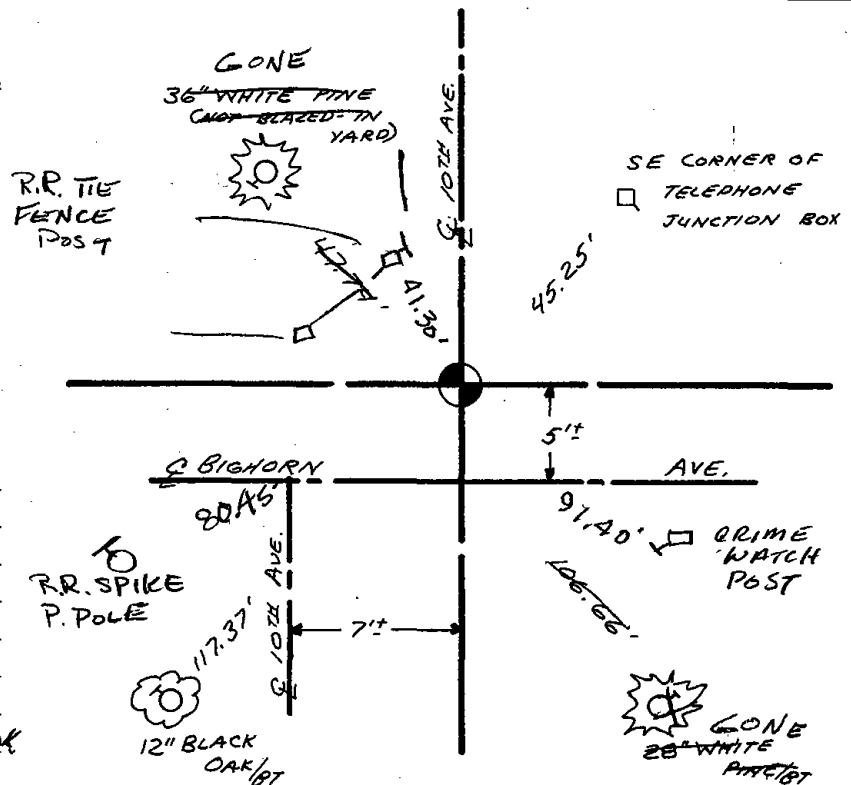
TIE SKETCH

No record of resurveys. Excavated large area with backhoe. Found nothing. Corner set by analyzing a traverse a mile in all four directions from here.

Date	Init.	Remarks
3-10-83	GR-SS	OK
2-1-88	GR-SS	OK
1-4-93	JG-B5	OK
2-13-98	JG	OK
1-6-03	JG	OK
11-14-07	JG-JS	2-GONE 3-NEW, MON. OK
