ADAMS COUNTY COUNTY COUNTY CORNER NO: 59 ROMPORTOL ID: 41906142000

PUBLIC LAND SURVEY MONUMENT RECORD

Government Land Corner Certificate

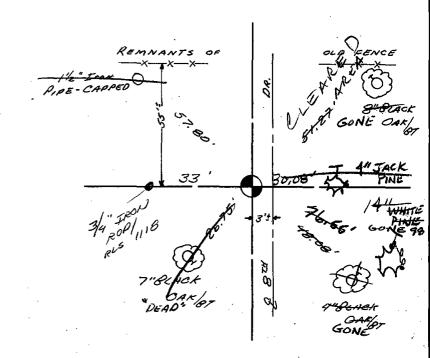
-TIE SKETCH

2018 - PLS 2675 FOUND A HARRISON MONUMENT WITH A BROKEN-TOP 14" BELOW THE ROAD SURFACE, 3 TIES AND 1 PROPERTY IRON, THE MONUMENT AGREES WITH THE EXISTING TIES, ACCEPTED THE HARRISON MONUMENT AS THE CORNER LOCATION AND MEASURED TO THE EXISTING TIES AND PROPERTY IRON.

NOTE: THE CORNER FALLS 2'± WEST OF THE CENTERLINE OF 8TH AVE.

OPEN YOUNG HARDWOODS ⟨⊕ S89° 26' 54"W N89° 19' 45"E 33.14' 33.04 YOUNG HARDWOODS

- FOUND 3/4" IRON ROD
- FOUND 1" IRON ROD
- FOUND HARRISON MONUMENT (BROKEN-TOP)
- STEEL FENCE POST
