OG RANGE ADAMS COUNTY CORNER NO: 118 ROMPORTOL ID: 41906342000

PUBLIC LAND SURVEY MONUMENT RECORD

HARRISON (BROKEN-TOP) TYPE OF MONUMENT: ADAMS COUNTY COORDINATES, NAD 83 (2007) N. 258582.216 E. 546635.902 DATUM 12/17/2018 FIELD WORK DATE:

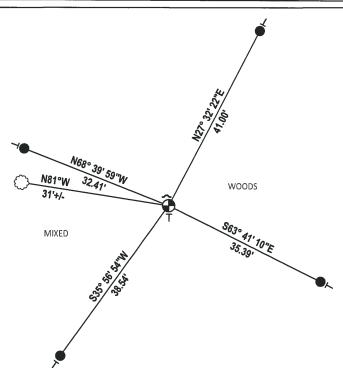
-TIE SKETCH

2018 - PLS 2675 FOUND A HARRISON MONUMENT WITH A BROKEN-TOP 2" BELOW THE GROUND SURFACE AND 1 WITNESS TREE. THE MONUMENT AGREES WITH THE EXISTING WITNESS TREE. ACCEPTED THE HARRISON MONUMENT WITH A BROKEN-TOP AS THE CORNER LOCATION. SET 4 NEW TIES AND MEASURED TO THE TIES AND WITNESS TREE.

- SET 3/4" x 18" IRON REBAR, 1.50#/FT
- FOUND HARRISON MONUMENT (BROKEN-TOP)
- STEEL FENCE POST
- VINYL "T" POST
- WITNESS TREE
