ADAMS COUNTY

PUBLIC LAND SURVEY MONUMENT RECORD

05 SECTION 19 TOWN 07 RANGE

COUNTY CORNER NO: 25
 ROMPORTOL ID: 41907050000

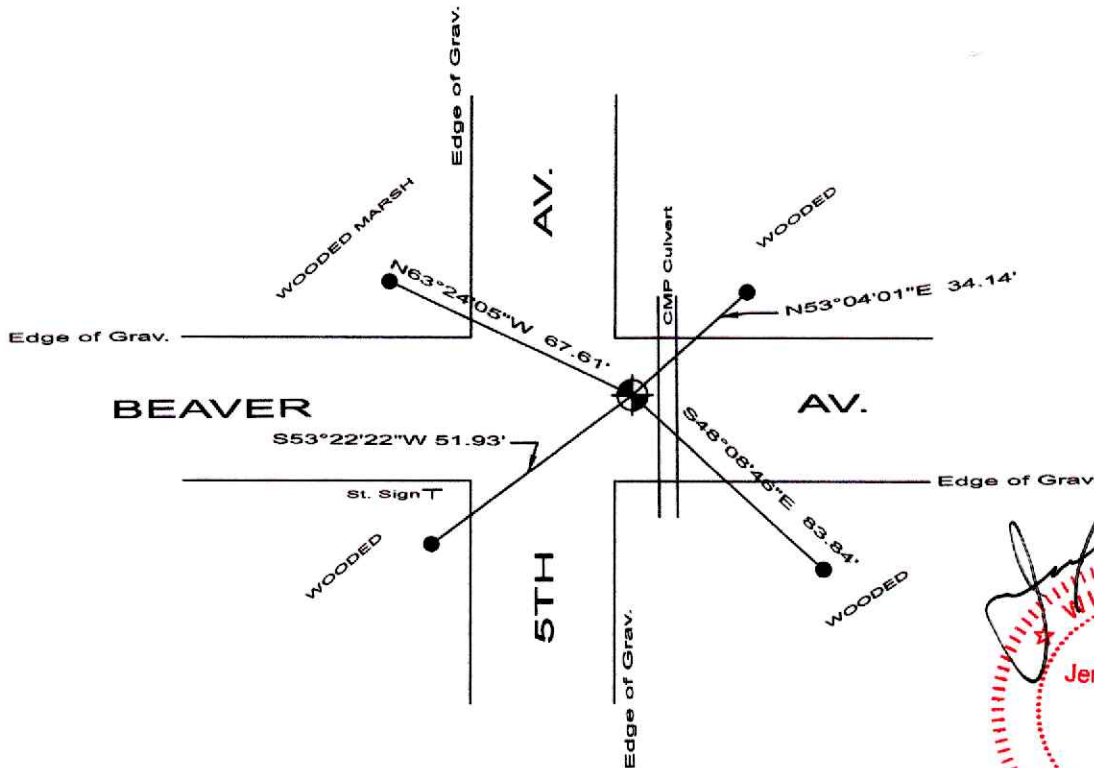
- 1974 - PLS 878 found no evidence of previous monumentation after excavation. Set Harrison monument after traversing entire section.
- 2019 - PLS 2675 found Harrison monument with broken top 6" below surface of road. Accepted Harrison and set 4 new ties.
- 2023 - PLS 1739 found 4 existing ties but no evidence of Harrison monument. A recent culvert had been installed close to the monument location. After fixing location from ties and excavating to a depth of 3' and finding no monument, set a 3/4"x24" rebar from ties, 8" below surface of gravel road.

- Set 3/4"x24" iron rod 8" below surface
- Found 3/4" iron rod & Carsonite post

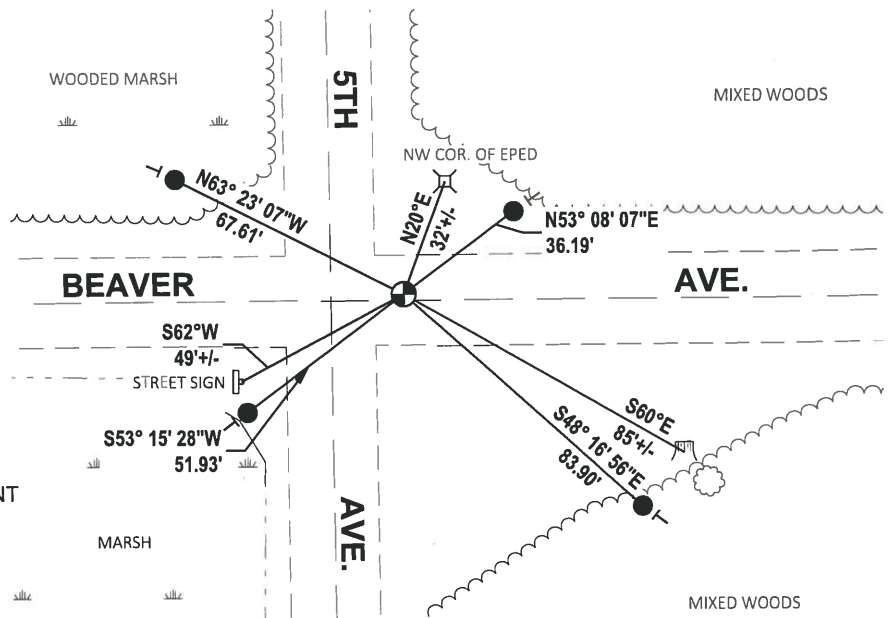
TIE SKETCH

2019 - PLS 2675 FOUND HARRISON (BROKEN-TOP) 6" BELOW THE ROAD SURFACE AND 3 WITNESSES. THE MONUMENT AGREES WITH ALL 3 WITNESSES. ACCEPTED THE HARRISON (BROKEN-TOP) AS THE CORNER LOCATION. SET 4 NEW TIES AND MEASURED TO THE EXISTING WITNESSES.

NOTE: THE CORNER LANDS ±2' NORTH OF BEAVER AVE. CENTERLINE AND ±20' EAST OF 5TH AVE. CENTERLINE.

- SET 3/4" x 18" IRON REBAR, 1.50#/FT
- ⊕ FOUND HARRISON (BROKEN-TOP) MONUMENT
- ┆ VINYL "T" POST
- ☼ WITNESS TREE
- ☼ WITNESS STUMP

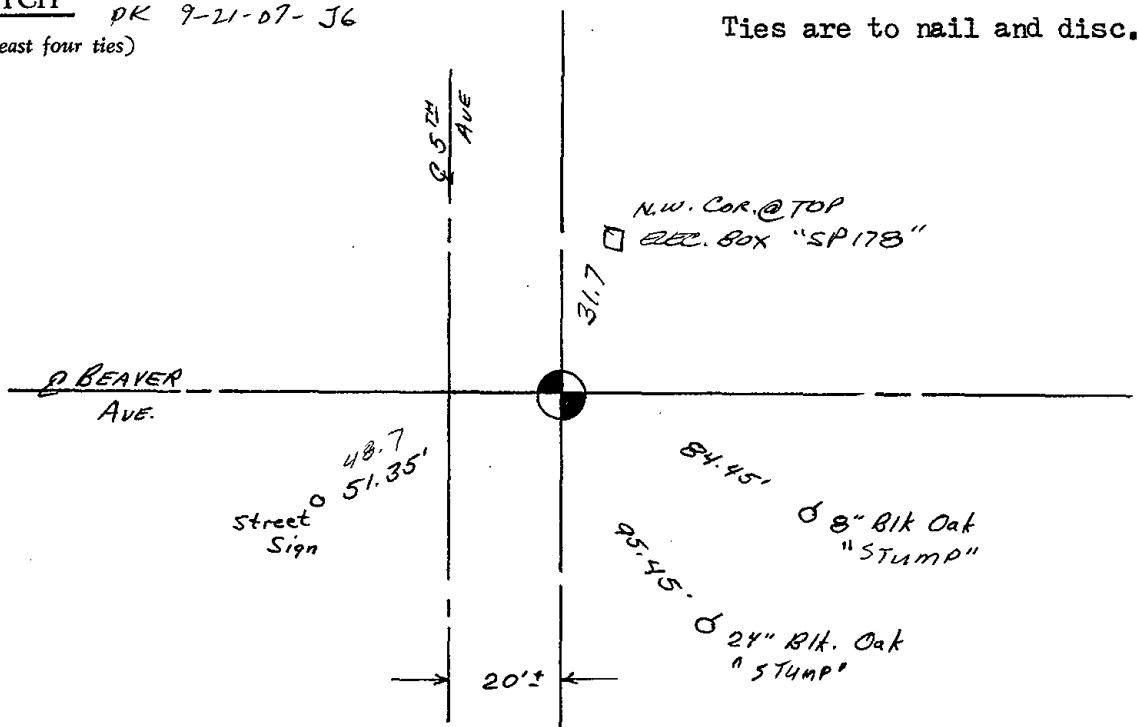
TIE SKETCH OK 1-03-02 JG
PK 7-21-07- JG
(Show at least four ties)

Excavated area with backhoe-found nothing.
Location determined by analyzing traverse
of entire section.

Ties are to nail and disc.
