31
SECTION

ADAMS COUNTY

COUNTY CORNER NO: 123

PUBLIC LAND SURVEY MONUMENT RECORD

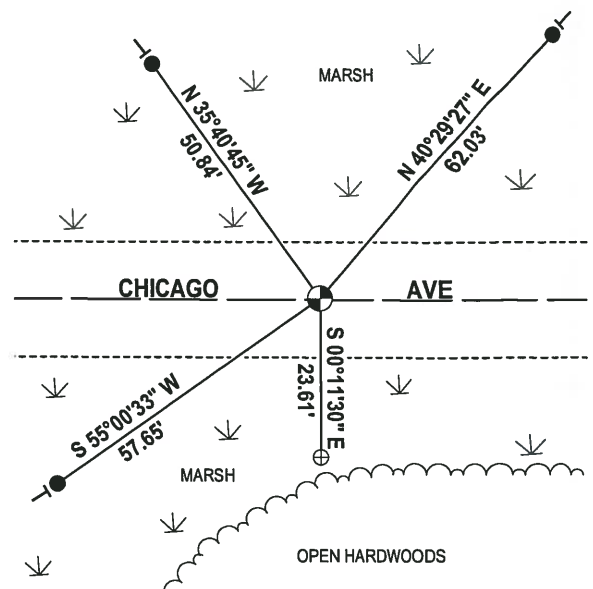
- TIE SKETCH

2018 - PLS 2994 FOUND A HARRISON MONUMENT WITH A BROKEN-TOP 8" BELOW THE ROAD SURFACE AND 1 TIE. THE MONUMENT AGREES WITH THE EXISTING TIE. ACCEPTED THE HARRISON MONUMENT WITH A BROKEN-TOP AS THE CORNER LOCATION. SET 3 NEW TIES AND MEASURED TO THE TIES.

NOTE: THE 1-1/4" WELL POINT IS ON THE NORTH EDGE OF A 10" WOODEN POST.

- 3/4" x 18" IRON REBAR SET, 1.50#/FT
- ⊕ 1-1/4" WELL POINT FOUND
- ⊙ HARRISON (BROKEN-TOP) FOUND
- VINYL "T" POST

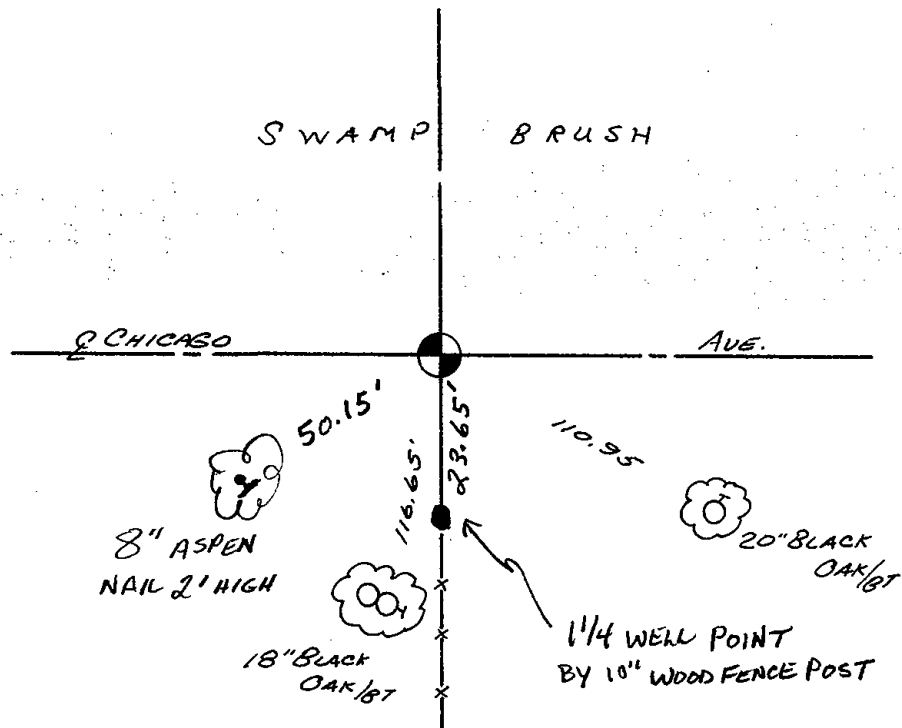
TIE SKETCH

Remonumented post with Harrison monument on 9-2-77.

Ties in trees to nail in disc.
