## PUBLIC LAND SURVEY MONUMENT RECORD

# Government Land Corner Certificate

CORNER NO. 79  
 SECTION 23  
 TOWN 20 N.  
 RANGE 5 E.

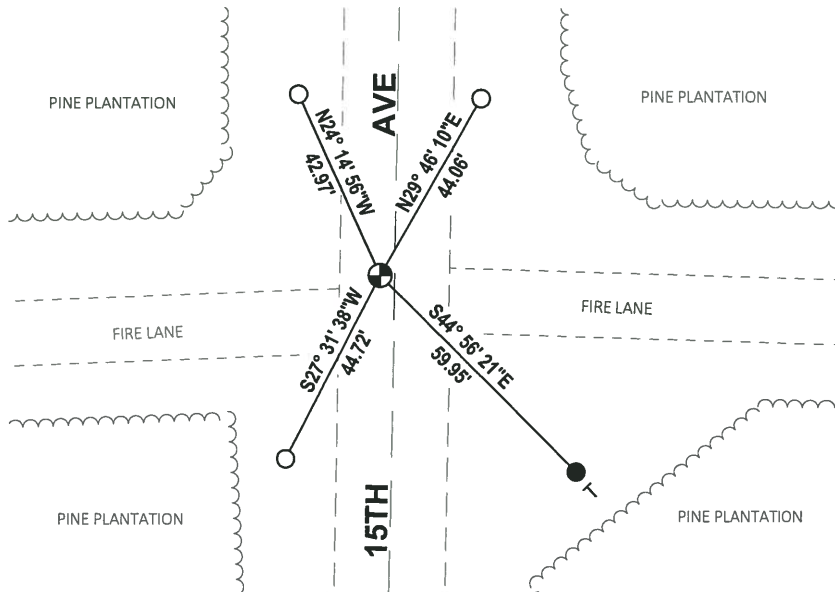
### TIE SKETCH

2018- PLS 2994 FOUND NO EVIDENCE OF ANY MONUMENT AT THE CORNER LOCATION. FOUND 3 EXISTING TIES AND CALCULATED THE CORNER LOCATION FROM THE 3 EXISTING TIES. THE TIE DISTANCE FIT WELL WITH EACH OTHER. SET A 3/4"x24" REBAR FOR THE CORNER 4" BELOW THE ROAD SURFACE. SET 1 NEW TIE AND MEASURED TO THE TIES.

NOTE: THE CORNER FALLS 4± WEST OF 15TH AVE CENTERLINE AND 9± NORTH OF THE CENTERLINE OF THE FIRE LANE.

- SET 3/4" x 18" IRON REBAR, 1.50#/FT
- FOUND 3/4" IRON ROD
- ⊕ SET 3/4" x 24" IRON ROD
- VINYL "T" POST

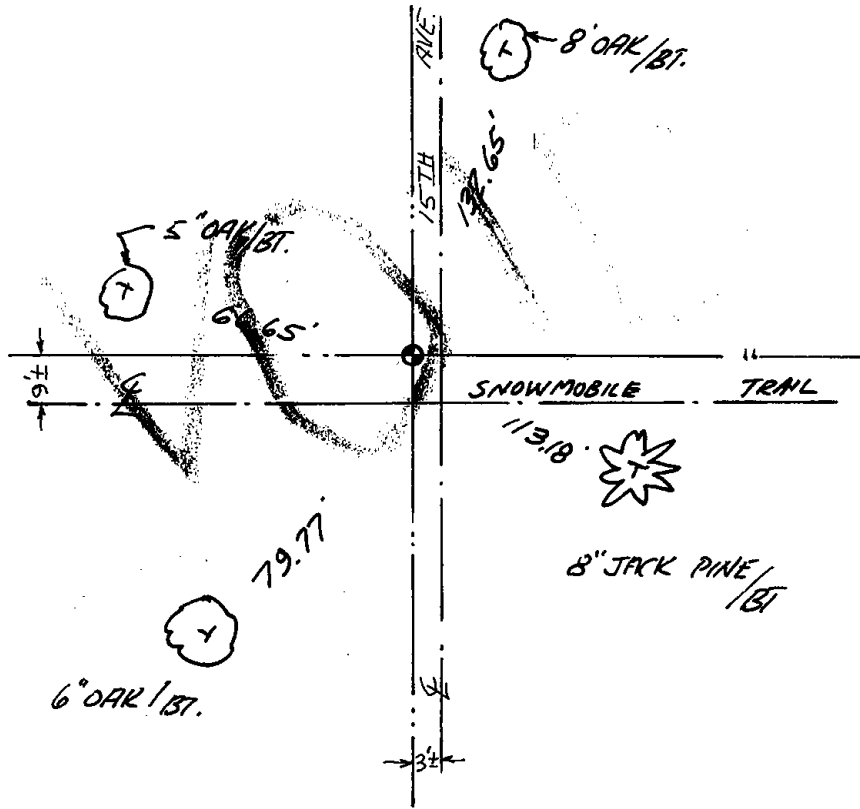
## TIE SKETCH

Set equidistant and on line between adjacent section corners.

No evidence of the original monument or its accessories was found.  
 No evidence of any subsequent remonumentation was found.

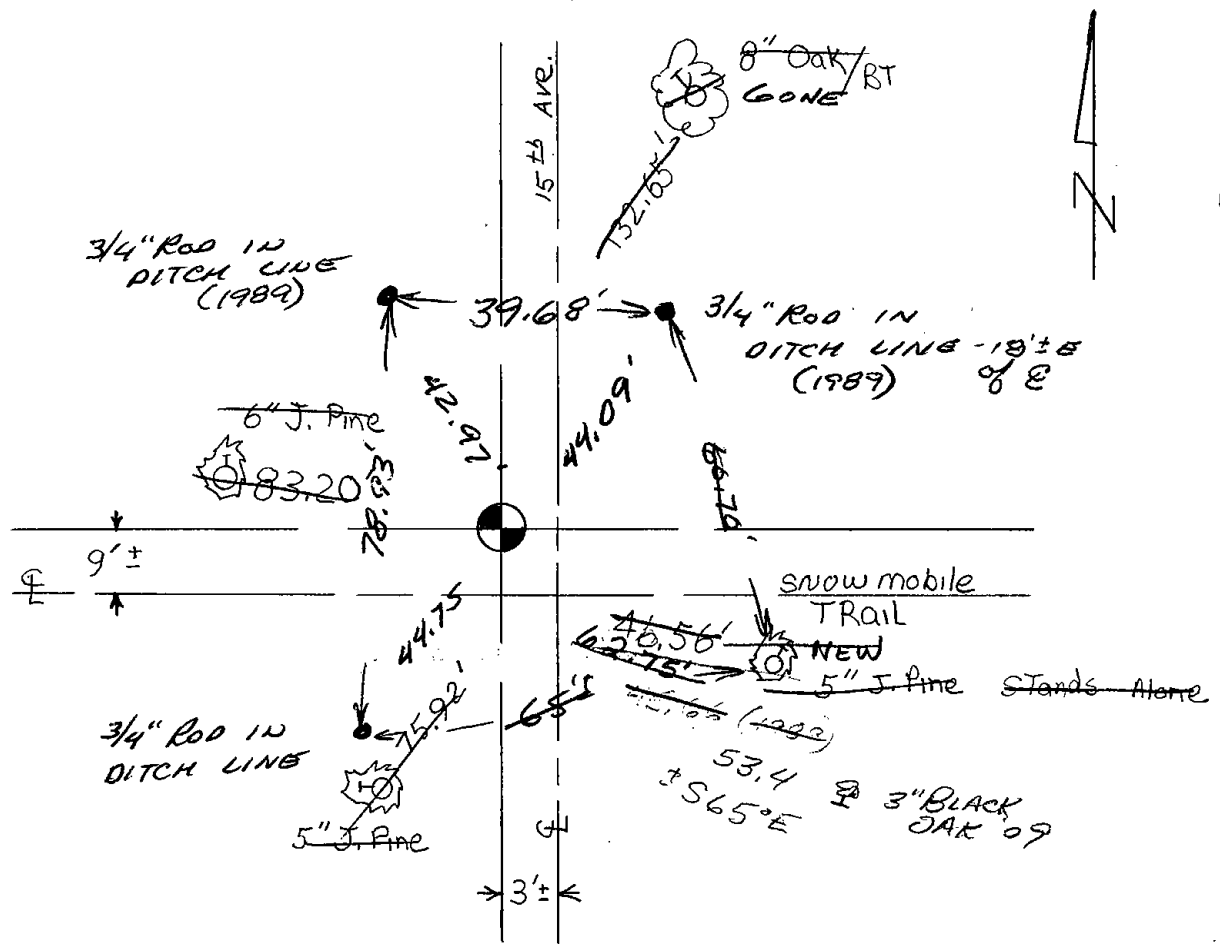
## MAINTENANCE RECORD

Map was updated on the 24th day of July 1984 Mk-SS

No harrison was found, however 2 one foot ties were found that matched the existing ties .

Ed. 3/4" Rod - SET 3- 3/4" RODS NEW TIES 6-12-89 MK-SS  
 OK 2-11-94 SS-CR  
 OK 12-29-98 - JG  
 2-GONE, 1-NEW, 2-26-04-JG  
 1 " 1 " 5-04-09 SS
