PUBLIC LAND SURVEY MONUMENT RECORD

TYPE OF MONUMENT: HARRISON (BROKEN-TOP)
ADAMS COUNTY COORDINATES, NAD 83 (2007)

Survey Monument Record

CORNER NO. 14

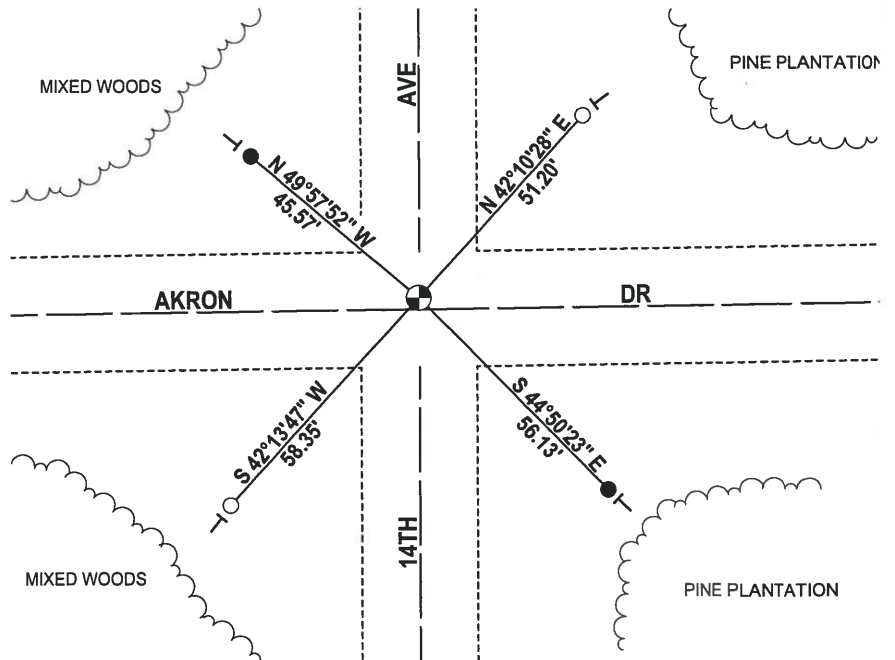
- TIE SKETCH -

2018 - PLS 2994 FOUND HARRISON WITH A BROKEN-TOP 18" BELOW THE ROAD SURFACE AND 2 TIES. THE MONUMENT AGREES WITH TIES. ACCEPTED THE HARRISON WITH BROKEN-TOP AS THE CORNER. SET 2 NEW TIES AND MEASURED TO THE TIES.

NOTE: THE CORNER FALLS 2± NORTH OF THE CENTERLINE OF AKRON DR.

- 3/4" x 18" IRON REBAR SET, 1.50#/FT
- 3/4" IRON ROD FOUND
- ⊙ HARRISON (BROKEN-TOP) FOUND
- ⊣ VINYL "T" POST

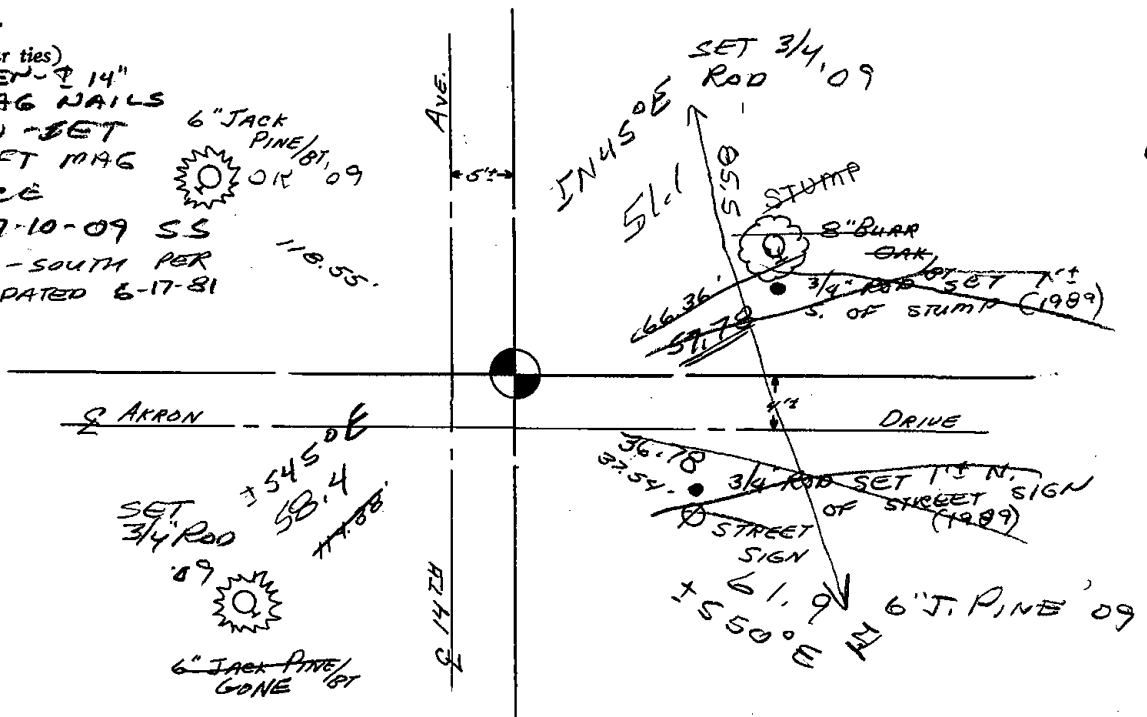
TIE SKETCH

Excavated with backhoe. Found nothing. No resurveys of record. Corner set on a straight line between section corners, but not proportional. Could not match possession lines by 30'±. Therefore took possession lines into consideration in setting the north-south location of this corner.

FD HAR-TSP BROKEN - 14"
DEEP - USED MAG NAILS
1' TIE NE FAW - SET
RR SPIKE, LEFT MAG
NAILS IN PLACE
3 NEW TIES 07-10-09 SS
VERIFIED NORTH-SOUTH PER
KEL SUMMARY DATED 6-17-81
