ADAMS COUNTY COUNTY CORNER NO: 29

ROMPORTOL ID: 42006030000

PUBLIC LAND SURVEY MONUMENT RECORD

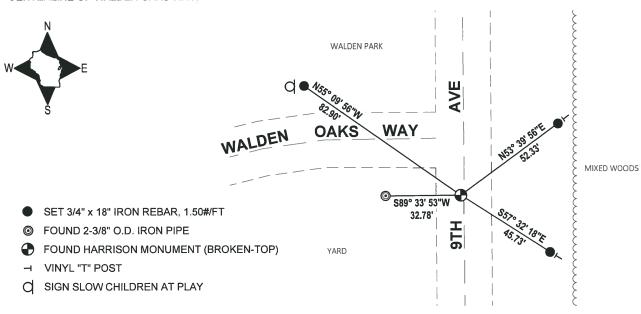
-TIE SKETCH

2018 - PLS 2994 FOUND A HARRISON MONUMENT WITH A BROKEN-TOP 8" BELOW THE ROAD SURFACE. FOUND NO EVIDENCE OF ANY OF THE WITNESSES. ACCEPTED THE HARRISON MONUMENT WITH A BROKEN-TOP AS THE BEST EVIDENCE OF THE CORNER LOCATION. SET 4 NEW TIES AND MEASURED TO THE TIES.

NOTE: THE CORNER FALLS 2'± WEST OF THE CENTERLINE OF 9TH AVE AND 24'± SOUTH OF THE CENTERLINE OF WALDEN OAKS WAY.
