## PUBLIC LAND SURVEY MONUMENT RECORD

TYPE OF MONUMENT: HARRISON (BROKEN-TOP)  
ADAMS COUNTY COORDINATES, NAD 83 (2007)

# Government Land Corner Certificate

CORNER NO. 99  
 SECTION 25  
 TOWN 20  
 RANGE 6

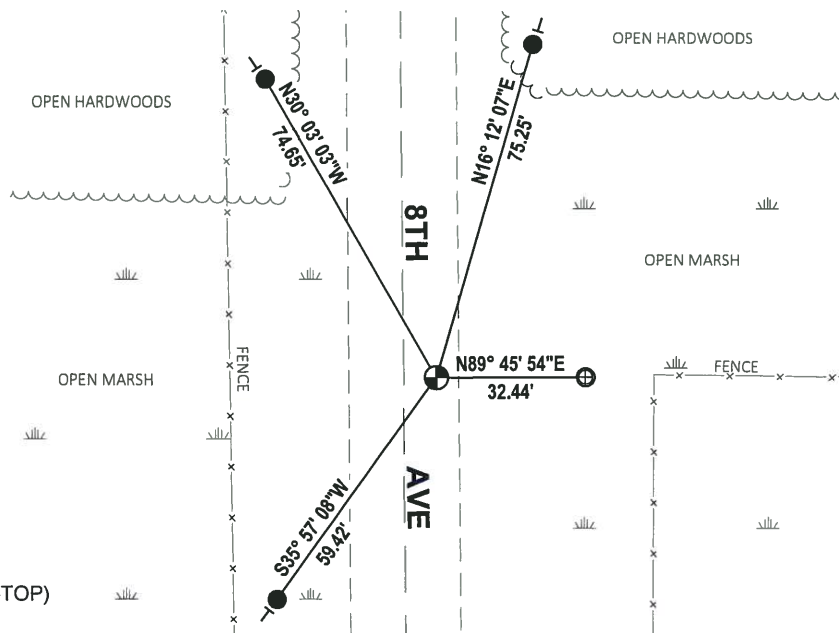
### - TIE SKETCH

2018 - PLS 2994 FOUND A HARRISON MONUMENT WITH A BROKEN-TOP 4" BELOW THE ROAD SURFACE AND 1 TIE. THE MONUMENT AGREES WITH THE EXISTING TIE. ACCEPTED THE HARRISON MONUMENT WITH A BROKEN-TOP AS THE CORNER LOCATION. SET 3 NEW TIES AND MEASURED TO THE TIES.

NOTE: THE CORNER FALLS 7'± EAST OF THE CENTERLINE OF 8TH AVE.

- SET 3/4" x 18" IRON REBAR, 1.50#/FT
- ⊕ FOUND 1" O.D. IRON PIPE
- ⊕ FOUND HARRISON MONUMENT (BROKEN-TOP)
- VINYL "T" POST

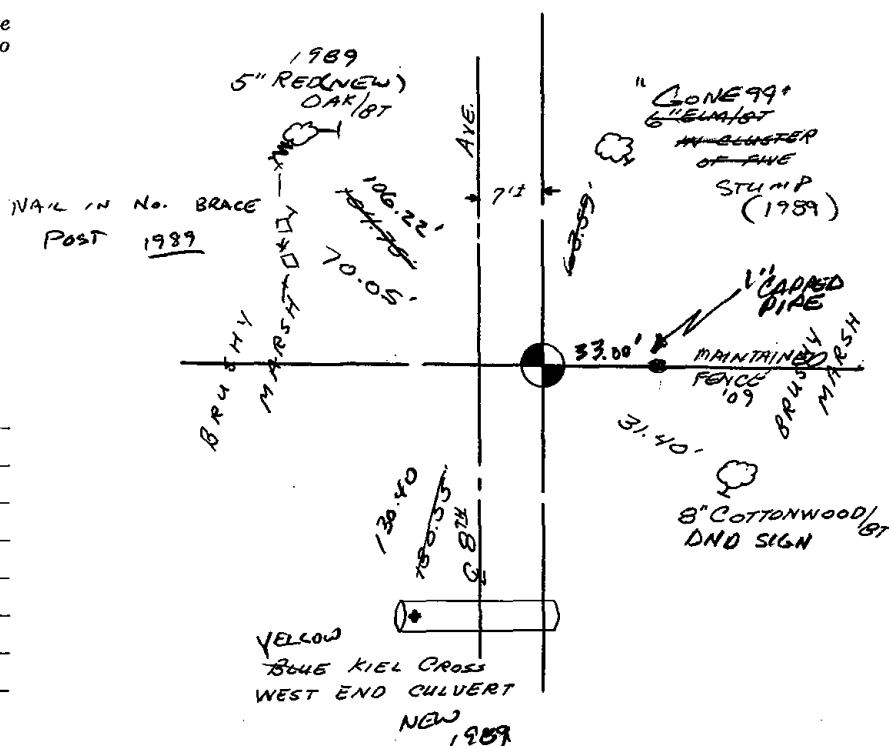
## TIE SKETCH

Ran EDM/T2 traverse around Section 25 and parts of adjoining sections to determine search area for investigation.

Excavation with backhoe by Anthony B. Kiedrowski, Adams County Surveyor, yielded no evidence of the original corner or any remonumentation. Could find no evidence of bearing trees.

Relocated corner by single proportionate measure on line between adjacent section corners.

Set Harrison on 11-9-77.

Ties in trees to nail in disc.
