04 SECTION 20 TOWN 07 RANGE

# ADAMS COUNTY

COUNTY CORNER NO: 06  
ROMPORTOL ID: 42007049020

## PUBLIC LAND SURVEY MONUMENT RECORD

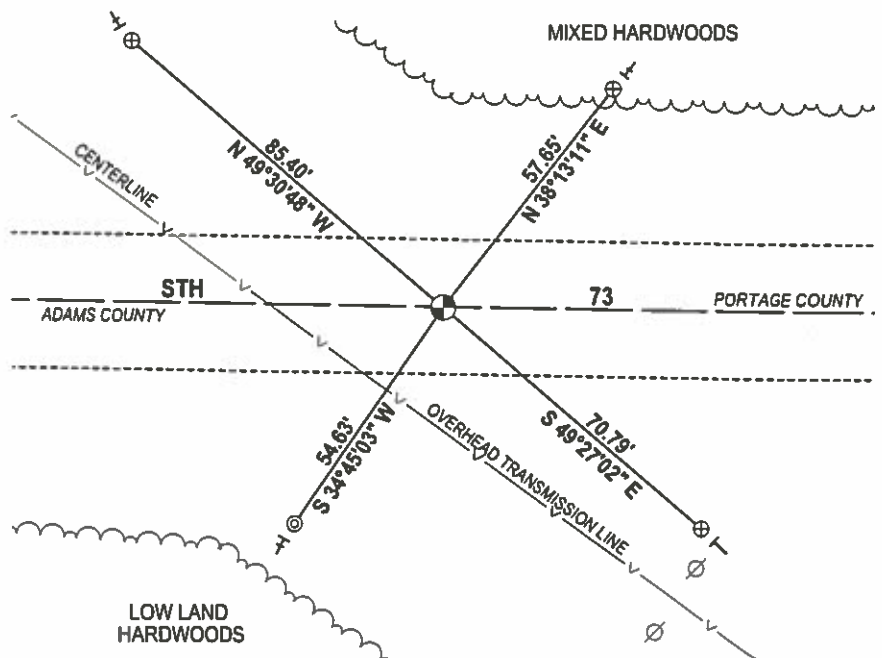
### TIE SKETCH

2017 - PLS 2994 FOUND EXISTING 1" OD IRON PIPE 8 INCHES BELOW THE ROAD, 4 EXISTING TIES, THE 1" IRON PIPE AGREES WITH THE TIES AND ACCEPTED THE 1" OD IRON PIPE. REMEASURED TO THE TIES.

NOTE: THE CORNER FALLS 1½ SOUTH OF THE CENTERLINE OF STH 73.

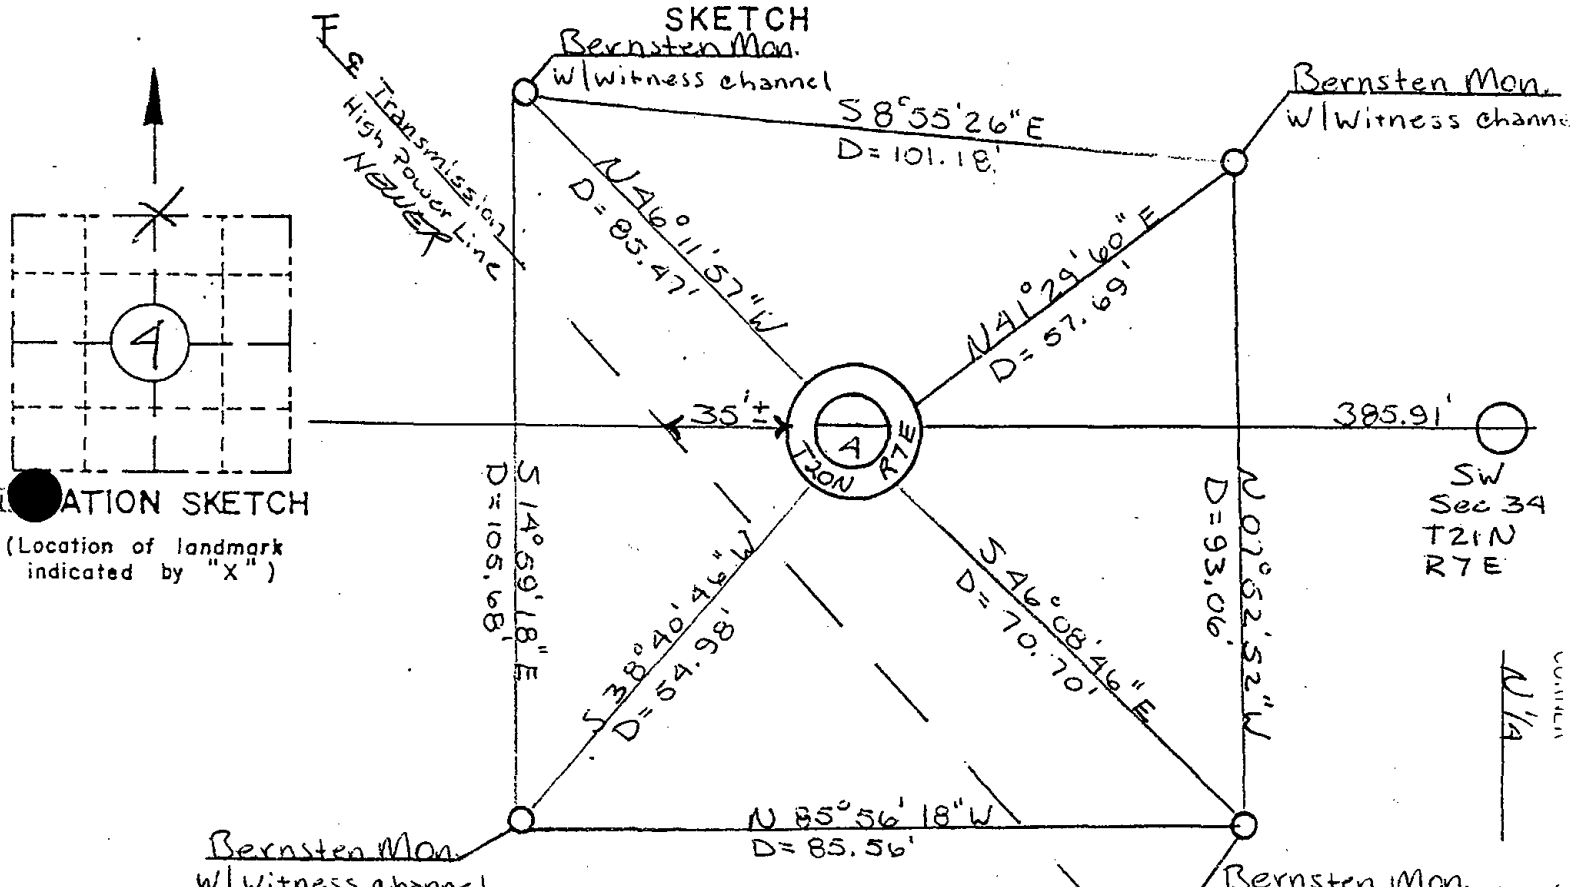
I hereby certify that on the 4<sup>th</sup> day of April 1999, that I did locate the above corner which was evidenced by Alum. Hwy. cap.

; I further certify that I did establish 4 references or witness monuments consisting of Bernsten Monument w/witness channel

ALL OK 3-28-99 JG-GR  
OK 2-22-99-JG  
WITNESS MON. OK 12-10-04  
" " " 7-7-09 55

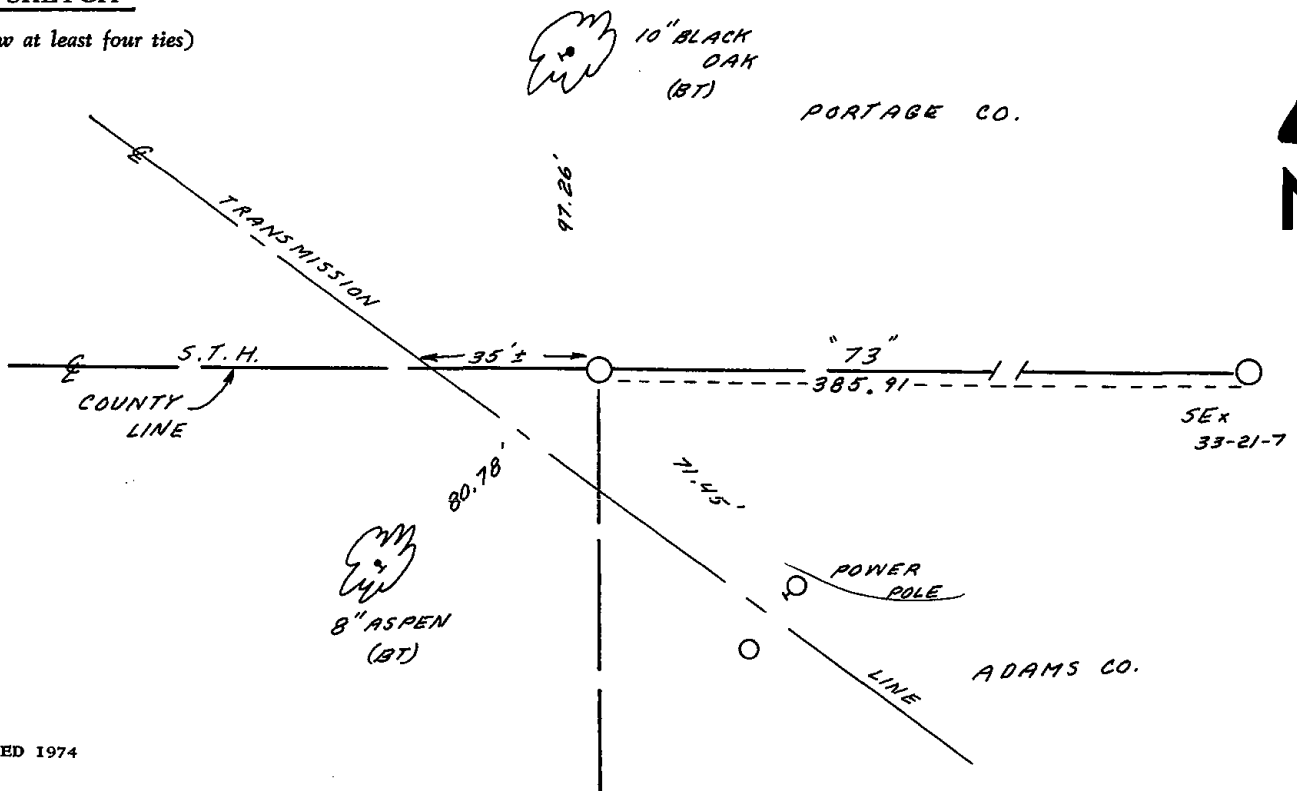
TIE SKETCH

Set equidistant between the NE and NW corners of Section 4, and on line between the SE and S $\frac{1}{4}$  corners of Sec. 33-21-7. No evidence or record of this corner ever having been set.

TIES & MON. O.K. 3-23-79 D.W. - R.N.  
SEE ATTACHED PAGE ALSO 4-4-91
