# ADAMS COUNTY

COUNTY CORNER NO: 15

## PUBLIC LAND SURVEY MONUMENT RECORD

# Government Land Corner Certificate

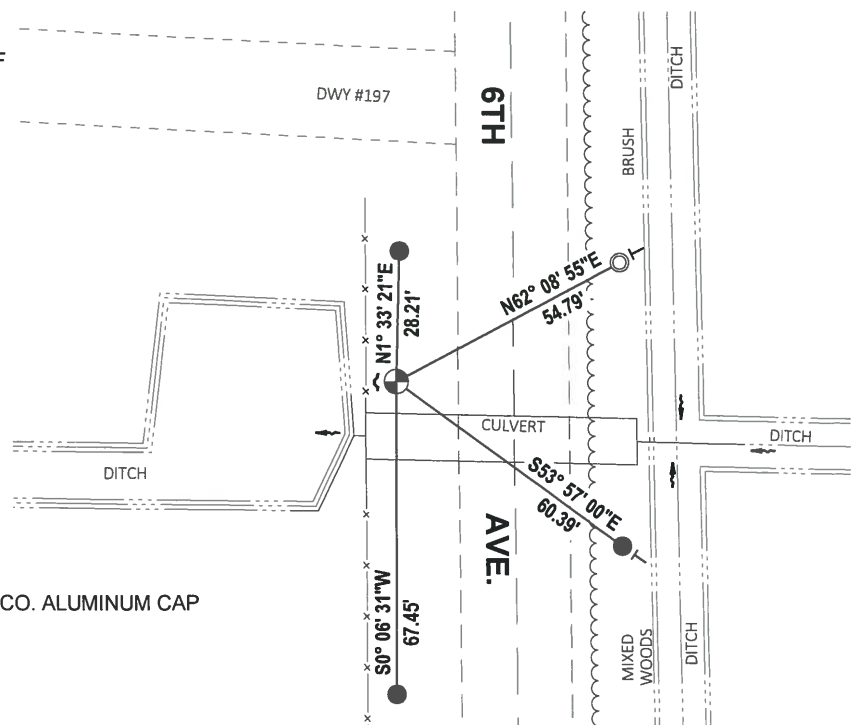
### - TIE SKETCH

2020 - PLS 2675 FOUND HARRISON MONUMENT 6"± BELOW THE GROUND AND 1 TIE THAT HAD BEEN TIPPED. THE MONUMENT AGREES WITH THE TIE. ACCEPTED THE HARRISON MONUMENT AS THE CORNER LOCATION. SET 3 NEW TIES AND MEASURED TO THE EXISTING TIE.

NOTE1: THE CORNER LANDS 25'± WEST OF THE CENTERLINE OF 6TH AVE.  
NOTE2: TIES ALONG FENCE ARE 1'± EAST OF THE 8' TALL FENCE.

- SET 3/4" x 18" IRON REBAR, 1.50#/FT
- FOUND 1-1/4" O.D. IRON PIPE W/ADAMS CO. ALUMINUM CAP
- ⊕ FOUND HARRISON MONUMENT
- ✓ FIBERGLASS POST
- VINYL "T" POST

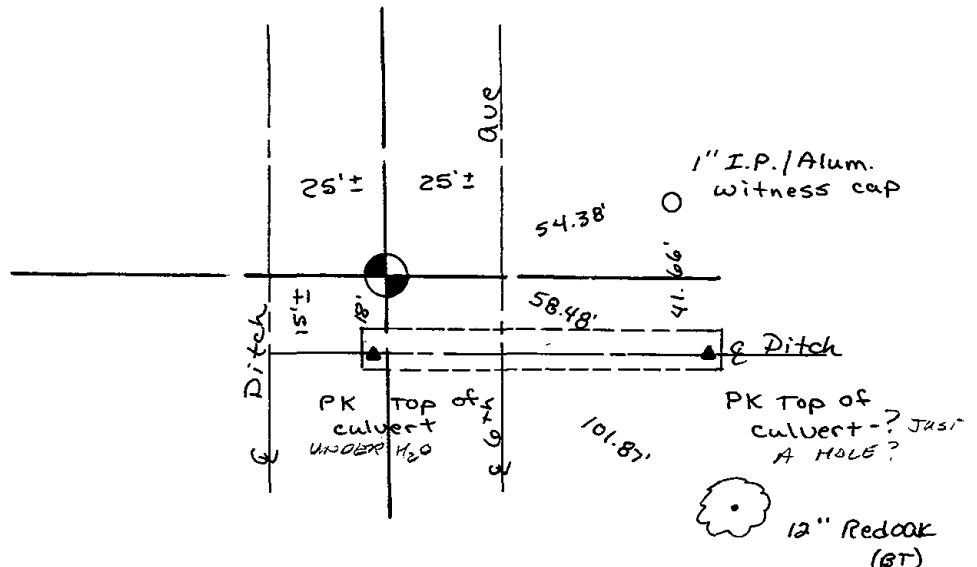
## TIE SKETCH

This corner was set on line and by single proportionate distance between adjacent Section corners. Did not excavate at this location because ditching would have destroyed any evidence.
