# ADAMS COUNTY

COUNTY CORNER NO: 30

## PUBLIC LAND SURVEY MONUMENT RECORD

TYPE OF MONUMENT: HARRISON (BROKEN-TOP)

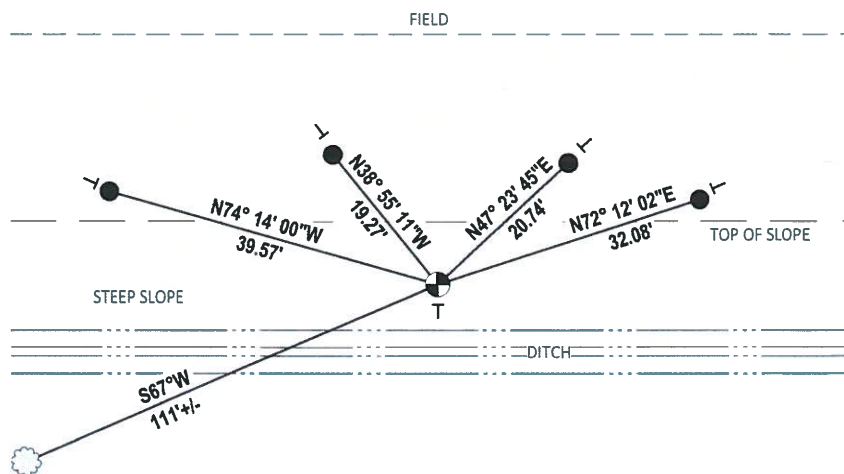
### TIE SKETCH

2020 - PLS 2675 FOUND HARRISON (BROKEN-TOP) 4"± BELOW THE GROUND AND 1 WITNESS. THE MONUMENT AGREES WITH THE WITNESS AND WAS VERIFIED TO BE ON A NEAR STRAIGHT LINE AND EQUIDISTANT BETWEEN THE SE AND SW CORNERS OF SECTION 2. ACCEPTED THE HARRISON (BROKEN-TOP) MONUMENT AT THE CORNER LOCATIONS. SET 4 NEW TIES AND MEASURED TO THE EXISTING WITNESS.

- SET 3/4" x 18" IRON REBAR, 1.50#/FT
- ⊕ FOUND HARRISON (BROKEN-TOP) MONUMENT
- └ VINYL "T" POST
- ☉ WITNESS TREE

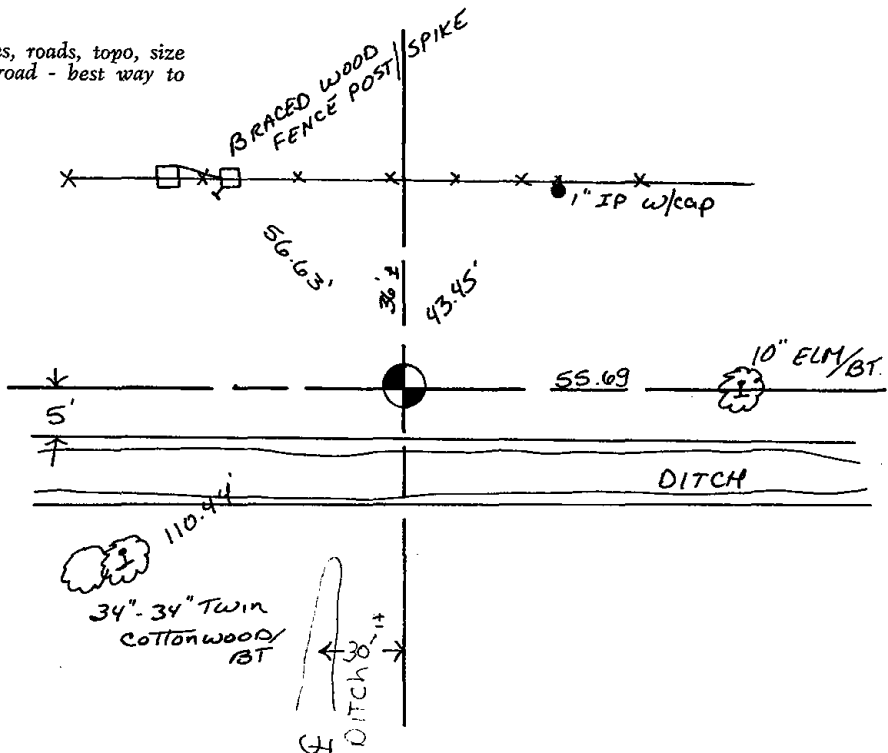
## TIE SKETCH

Set corner equidistant and on line between the SW corner of Section 2 and the SE corner of Section 2. Searched for bearing trees, none remain. All evidence of corner destroyed by ditch. No resurveys of record.
