ADAMS COUNTY

COUNTY CORNER NO: 116
ROMPORTOL ID: 42007322000

PUBLIC LAND SURVEY MONUMENT RECORD

Survey Monument Record

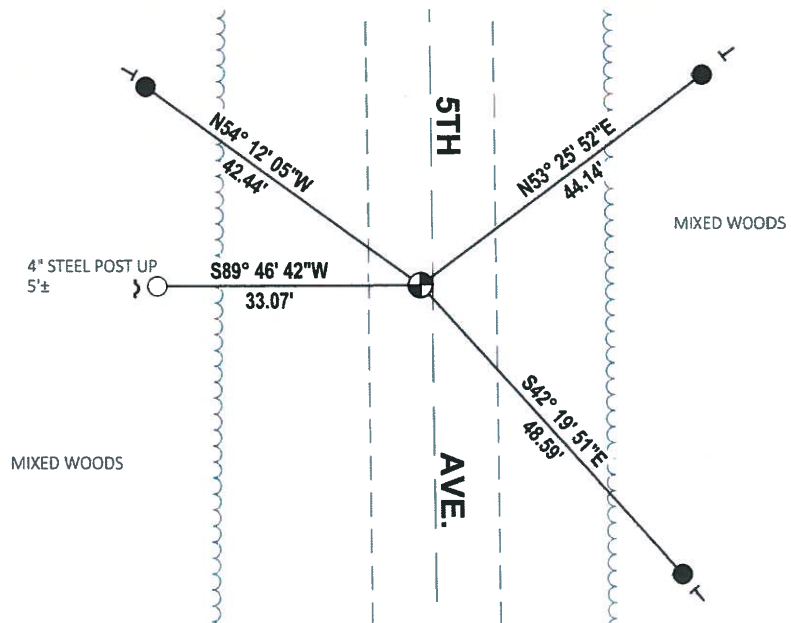
TIE SKETCH

2020 - PLS 2675 FOUND HARRISON (BROKEN-TOP) 6"± BELOW THE ROAD AND 1 TIE. THE MONUMENT AGREES WITH THE TIE. ACCEPTED THE HARRISON (BROKEN-TOP) AS THE CORNER LOCATION. SET 3 NEW TIES AND MEASURED TO THE EXISTING TIE.

NOTE: THE CORNER LANDS 1.4'± WEST OF 5TH AVE. CENTERLINE

- SET 3/4" x 18" IRON REBAR, 1.50#/FT
- FOUND 3/4" IRON ROD
- ⊕ FOUND HARRISON (BROKEN-TOP) MONUMENT
- ~ STEEL FENCE POST
- VINYL "T" POST

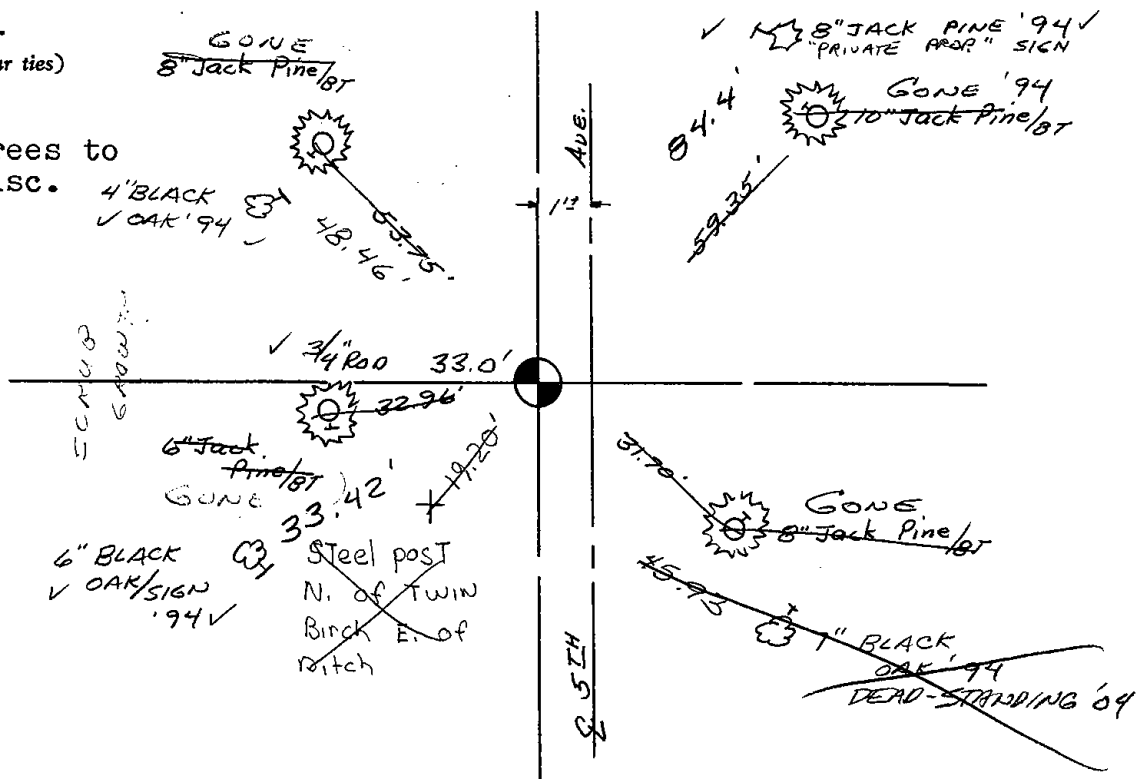
TIE SKETCH

OK 11-3-79 BS-SS
TOP BROKEN - 4 NEW TIES 3-21-94 JG-SS
OK 2-12-99-JG
OK 8-25-04 SS OK 2-6-09 SS

Ties in trees to nail in disc.
